Tree Condition Report

Plaistow Recreation Ground

July 2023

Ref: TCR/451/23

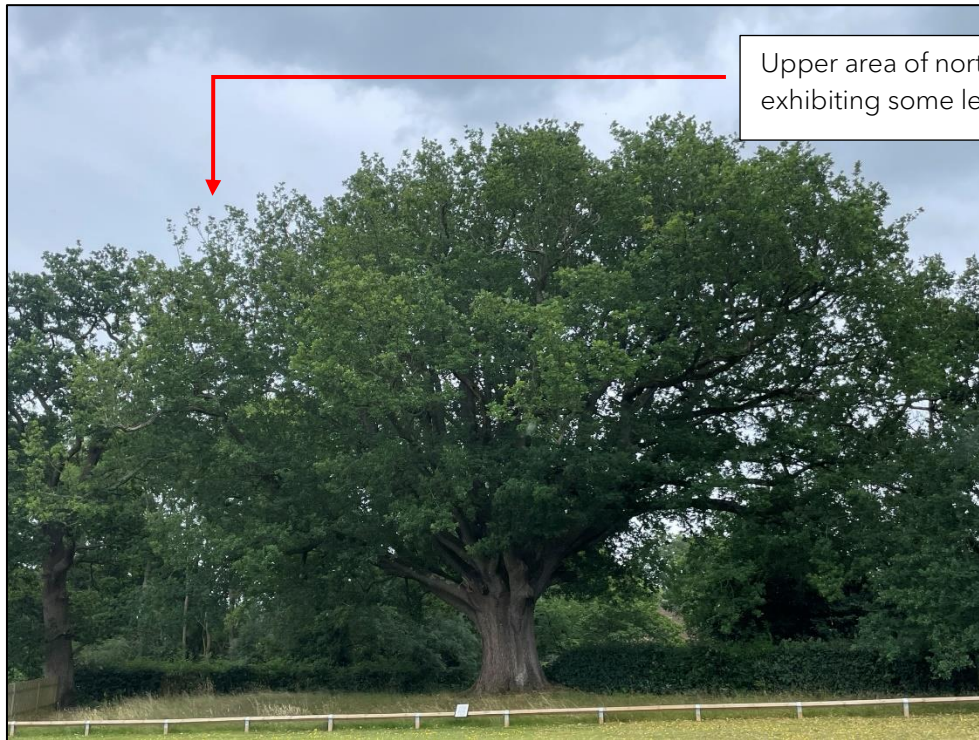
- A c.9m long section of deadwood, emanating from a secondary stem section, was noted heading across Common House Road
- The tree was recorded as having a FAIR physiological condition. This has changed from the previous survey as an area of decreased leaf material was noted in the upper northern crown with further patches of decreased leaf in the upper western crown - see Appendix 4 Site Photos

Upper area of northern crown exhibiting some leaf disorder

- Maintain the current schedule for the follow up decay evaluation for May 2025 as recommended in TCR/297/22
- This time frame should be shortened in the event:

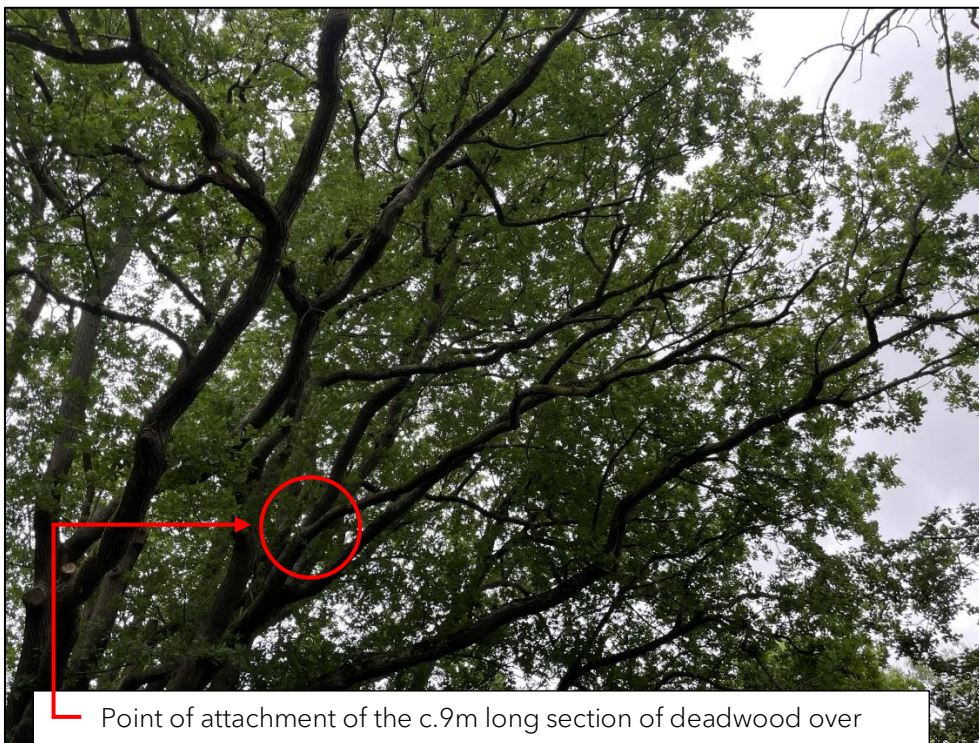
Point of attachment of the c.9m long section of deadwood over Common House Road

- Remove the c.9m long section of deadwood from over Common House Road, to be undertaken as soon as practicable
- It is worth noting that although the tree is subject to a tree preservation order (T7 of 70/00769/TPO) the removal of deadwood is exempt from the need to make a formal application. However, I would strongly recommend that prior to the work being undertaken, a photo of the dead section is emailed to the tree officer at Chichester District Council referencing the proposed works
