Gale Tree Consultancy

Tree Condition Report

Plaistow Recreation Ground

Ref: TCR/706/25

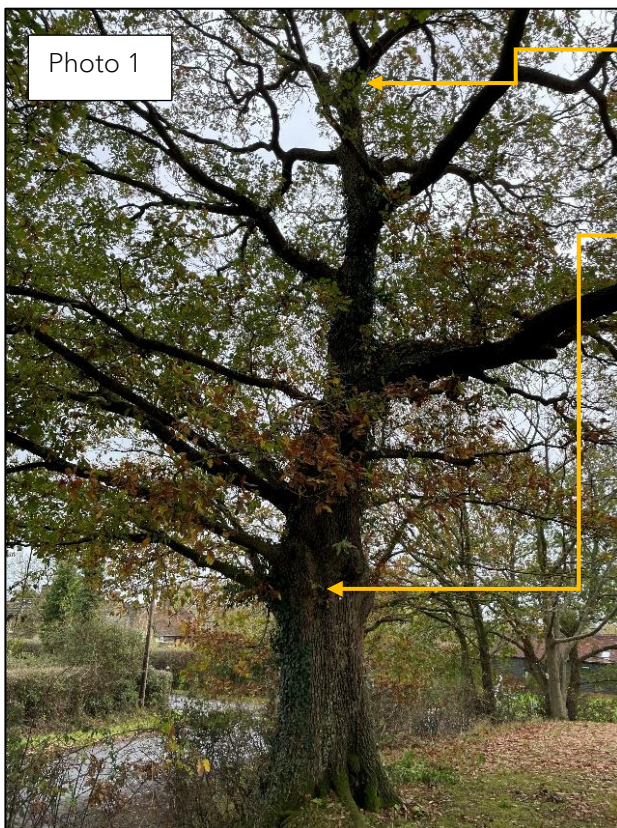
- Running directly to the east of the tree is a cut through path from Common House Road onto the recreation ground
- The tree has several cavities through the main stem, with one forming on a tertiary stem section in the upper crown - please see Photo 1 below

c.11m cavity on main stem

c.3m cavity on main stem

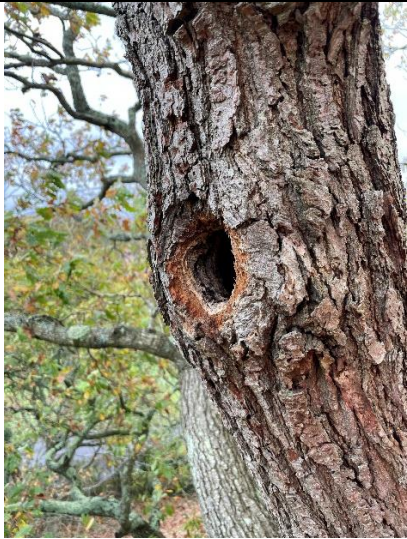
Cavity No.	Image	Height on tree in m	Aspect	Dia. in cm	Height in cm	Width in cm	Depth In in cm	Depth Up in cm	Depth Down in cm	Comments
C1

11.4	South	24	10	6	10	//	42	<p>Tertiary Stem Section - TSS</p> <p>Unable to assess extent of the cavity up the stem</p> <p>Light can be seen through the rear of the TSS</p> <p>Distance from the bottom of the cavity to the attachment point with the main stem section c.52cm</p> <p>Dull tone heard around the TSS</p>

- This can be seen in Cavity 3 where the adaptive tissues have fully occluded over the cavity which was initially identified in 2018
- Cavity 1 forming in a tertiary stem section does not have any wound wood developing around its outer edge. The bark around the aperture showing signs of damage suggesting a woodpecker or other cavity nesting bird is using it as a nest space – at the time of assessment no birds were present – see Photo 2 below

- Light could be seen through the rear of the stem section in what appears to be an occluding longitudinal crack, this suggests that in places the north side of the stem section is beginning to break apart – see Photo 3 below

- The growth from the stem section heads south over the lay-by/parking area and Common House Road meaning should it fail it could reach the area below if not caught by the lower branching structure

- The cavities with occluding wound wood require no further action
- The tertiary stem section where Cavity 1 is located will require shortening in length as any failure could result in it falling onto Common House Road or the lay-by/parking area beneath
- The branch should be shortened by c.2m as this will reduce the end weight/sway whilst retaining the nest feature
- This should be undertaken within 12 months of the report's date, but in line with the Wildlife and Countryside Act 1981, not within the nesting season which is regarded as 1st March – 31st August

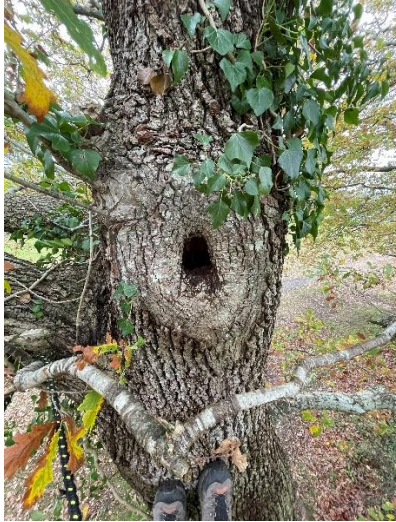
Cavity No.	Image	Height on tree in m	Aspect	Dia. in cm	Height in cm	Width in cm	Depth In in cm	Depth Up in cm	Depth Down in cm	Comments
C4

6.0	South	//	10	6	10	5	20	Main Stem Cavity forming at the point of a previous pruning wound Detritus in bottom of cavity Occluding wound wood developing Slight change in tone heard below the cavity when the area
C5

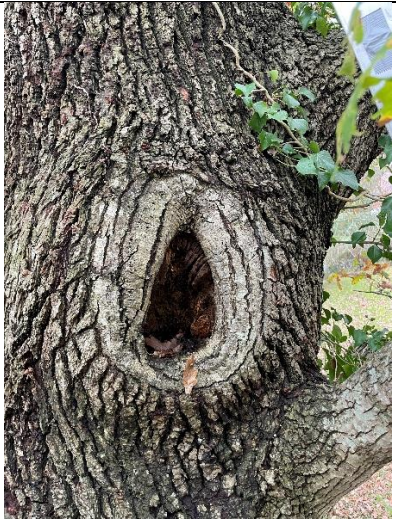
5.0	South East	//	22	13	11	//	5	Main Stem Cavity forming at the point of a previous pruning wound Detritus in bottom of cavity Exposed wood becoming friable Occluding wound wood developing No obvious changes in tone heard

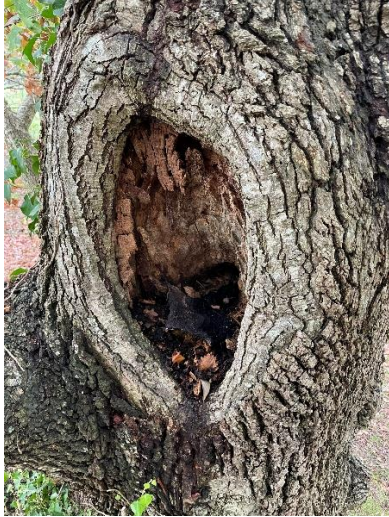
Cavity No.	Image	Height on tree in m	Aspect	Dia. in cm	Height in cm	Width in cm	Depth In in cm	Depth Up in cm	Depth Down in cm	Comments
C6

4.0	South East	94	55	25	52	//	15	<p>Main Stem</p> <p>Cavity forming at the point of a previous pruning wound</p> <p>Detritus in bottom of cavity</p> <p>Exposed wood becoming friable</p> <p>fruiting body of <i>Ceriporus squamosus</i> is present in the cavity</p> <p>Occluding wound wood developing</p>
C7

- The desiccated bracket of the decay fungus *Cerioporus squamosus* found in Cavity 6 shows that an active wood decay fungi is active within the cavity
- The fungus is associated with a selective white rot, where the lignin is removed in preference to the cellulose leading to cavity formation. When distributed over a large area of the main stem or branching structure, widespread dysfunction will develop which can result in stem/limb failure
- However, the cavity appears to be restricted the branch cone² of the removed stem section meaning that the tree's natural features may function as a barrier for the decay fungi's development

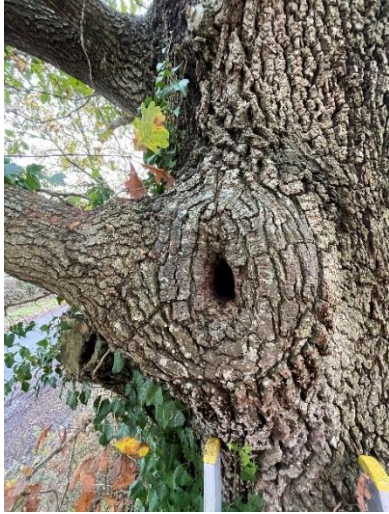
3.0	South East	//	8	5	45	//	15	<p>Main Stem</p> <p>Cavity forming at the point of a previous pruning wound</p> <p>Detritus in bottom of cavity</p> <p>Occluding wound wood developing - near fully occluded</p> <p>No obvious changes in tone heard</p>

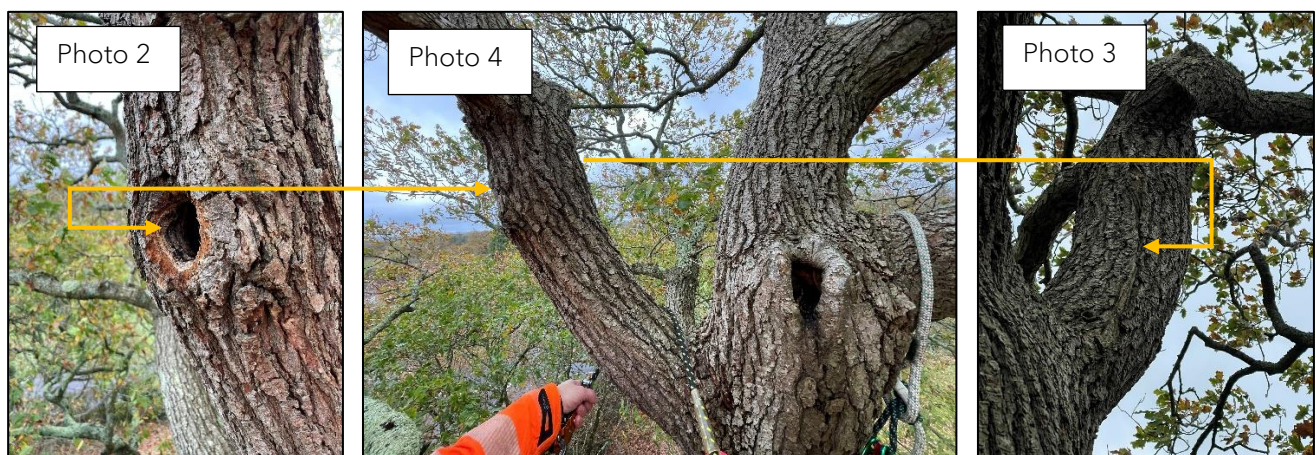
Cavity 1 at c.11.4m on a tertiary stem section over the neighbouring road
 Longitudinal crack on the north side where light can be seen
 Cavity 2 on the main stem at c.11m – see Photo 4

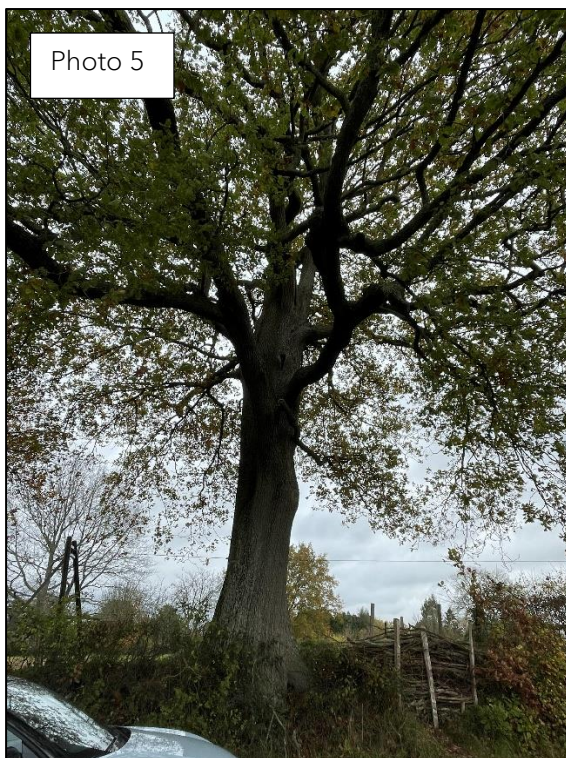
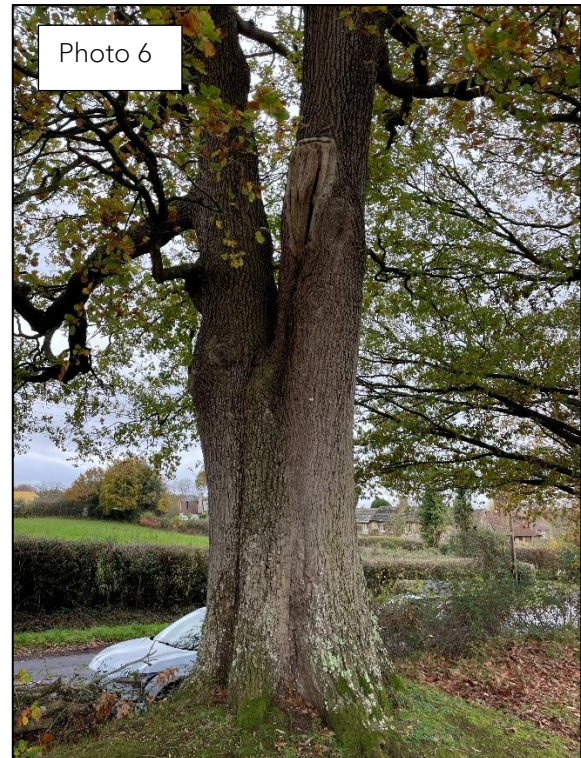
- The main stem forks at c.2.5m forming two primary stem sections in a north-to-south arrangement
- However, the union appears to manifest itself closer to the ground with adaptive growth being formed on the tree's east and west side of the stem
- The growth from the southern primary stem section predominately extends over Common House Road and the lay-by/parking area, and runs parallel with the hedge line beneath
- The northern crown spread heads over the aerial zip line

View from Common House Road showing the height difference with the recreation ground
Main stem and primary stem sections at c.2.5m

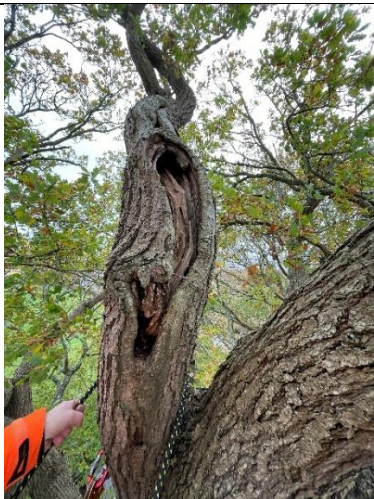
Cavity No.	Image	Height on tree in m	Aspect	Dia. in cm	Height in cm	Width in cm	Depth In in cm	Depth Up in cm	Depth Down in cm	Comments
C1

10.5	South	30	142	17	15	15	120	<u>Northern Primary Stem Section</u> Tertiary Stem Section Open wound on upper surface, cause unclear Occluding wound wood developing Obvious changes in tone heard Exposed wood becoming friable in nature
C2

- The upper teritary stem section home to Cavity 1 should also be reduced to reduce the end weight and lessen the risk of failure
- This should be undertaken within 12 months of the report's date, but in line with the Wildlife and Countryside Act 1981, not within the nesting season which is regarded as 1st March – 31st August

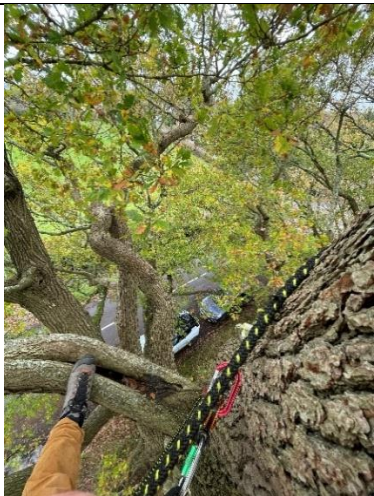
9.0	East	30	95	6	12	//	//	<u>Southern Primary Stem Section</u> Tertiary Stem Section Open wound on upper surface, cause unclear Occluding wound wood developing Obvious changes in tone heard Exposed wood becoming friable in nature Running parallel with the hedgerow

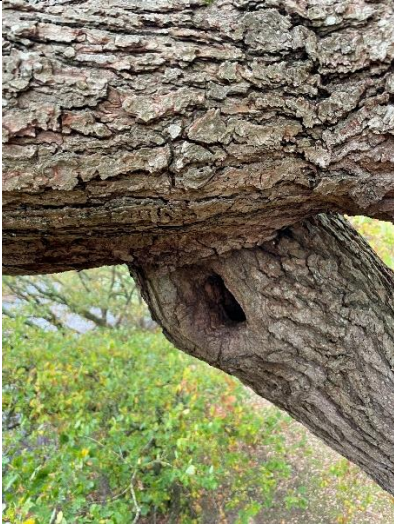
Cavity No.	Image	Height on tree in m	Aspect	Dia. in cm	Height in cm	Width in cm	Depth In in cm	Depth Up in cm	Depth Down in cm	Comments
C3

9.5	South	//	7	5	9	//	40	<u>Southern Primary Stem Section</u> Tertiary Stem Section Cavity forming on underside c.2.5m away from stem Occluding wound wood developing Slight change in tone heard Large wound being generated on upper surface from a tertiary stem section from the North Primary Stem Section resting and rubbing
C4

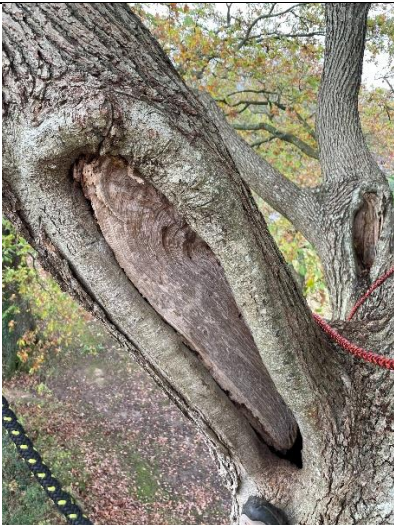
7.5	South East	//	85	15	14	//	80	<u>Southern Primary Stem Section</u> Tertiary Stem Section Tear out wound forming cavity at the junction with the secondary stem section Cavity extends into the secondary stem section Occluding wound wood developing Obvious and extensive changes in tone heard Exposed wood becoming friable in places

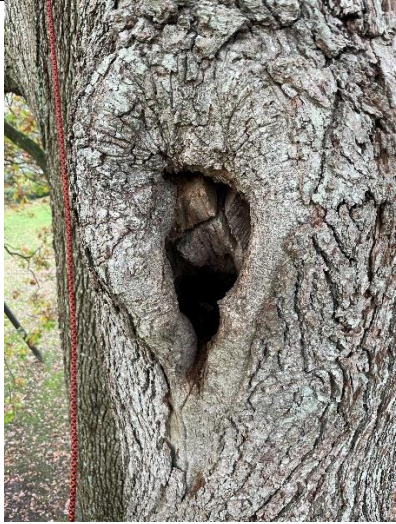
Cavity No.	Image	Height on tree in m	Aspect	Dia. in cm	Height in cm	Width in cm	Depth In in cm	Depth Up in cm	Depth Down in cm	Comments
C5

5.5	South	61	30	10	46	5	46	<u>Southern Primary Stem Section</u> Cavity forming at the point of a previous pruning wound/possible flush cut/area of storm damage Occluding wound wood developing around the cut marks c.1.2m below Cavity 4 Inner surface hard with detritus forming in the bottom of the cavity Obvious and extensive changes in tone heard
C6

- To limit the loading on the compromised tension wood, the southern crown spread should be shortened in length by c.2m to reduce the risk of failure across Common House Road or the lay-by/parking area beneath

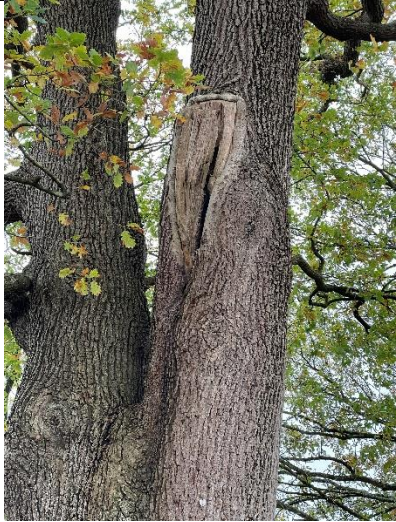
3.5	East	84	115	28	//	//	20	<u>Northern Primary Stem Section</u> Open wound forming from tear out or previous pruning operation Occluding wound wood developing Exposed wood beginning to delaminate

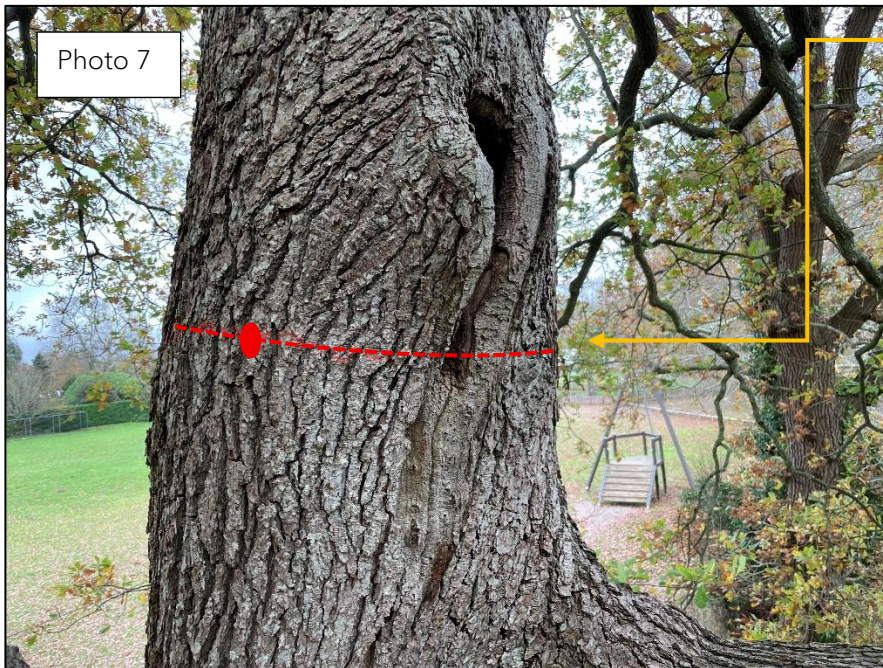
- To confirm the extent of the hollowing associated with Cavity 5, the Resi PD400 was used in four locations at the bottom of the cavity - please see Photo 7 below drill traces below:

Assessment height level with the bottom of the cavity

The red dot references the west drill spot - Drill Trace 4

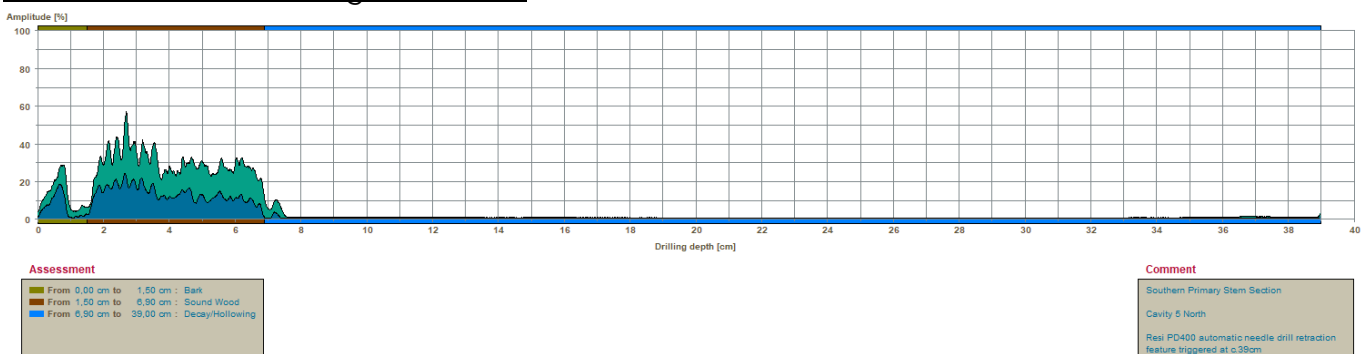
Drill Trace 1 - north drilling southwards

- Drill Trace 1 shows the narrowest depth of sound wood is on the north side of the stem at only c.6.1cm which means the tension wood is becoming compromised

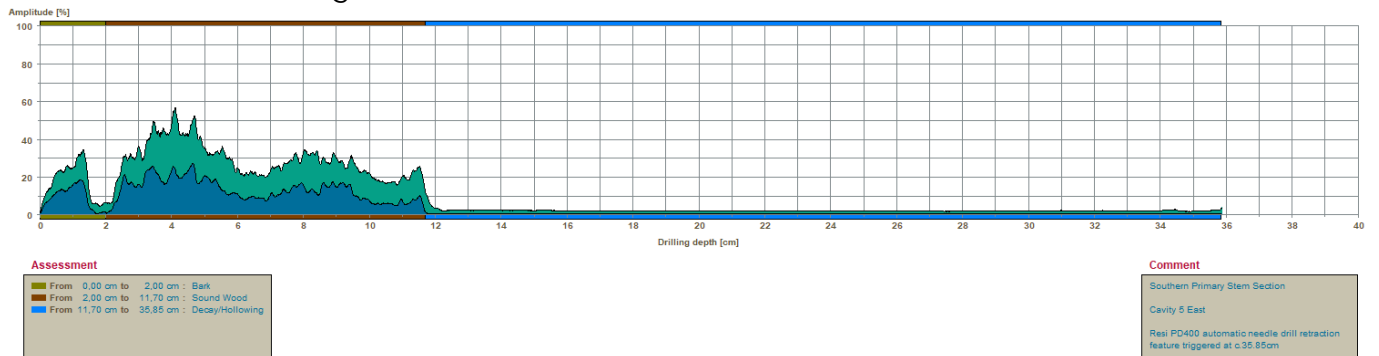
Drill Trace 2 - east drilling westwards

- Drill Traces 2 and 4 show an average depth of sound wood of c.13.65cm to the east and west of Drill Trace 1 which is helping to maintain the tension wood, but as these degrade, the risk of stem failure will increase
