# Gale Tree Consultancy

## Tree Condition Report

Winterton Hall, Loxwood Road, Plaistow

Ref: TCR/275/21

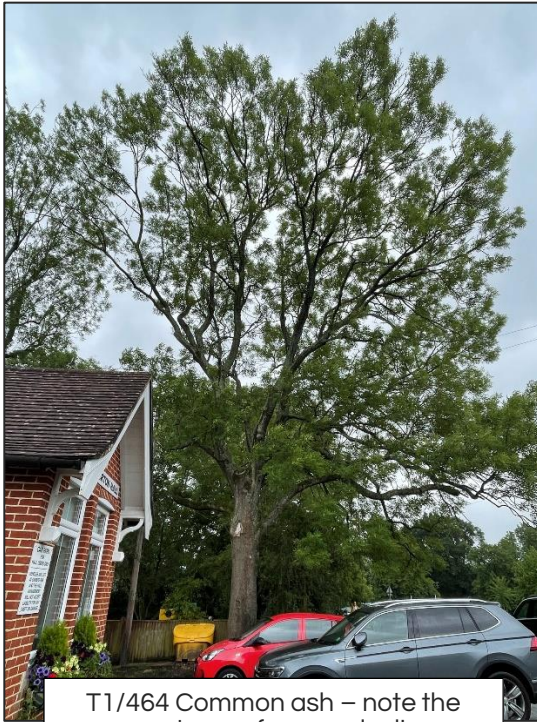
- T1/464 Common ash has a road de-icing salt storage bin located adjacent to the main stem – the yellow bin in the photo in Appendix 3
- Table 2.2 of the Forestry Commission’s Bulletin 101 De-icing Salt Damage to Trees and Shrubs suggests *Fraxinus excelsior* has an intermediate tolerance to the effects of de-icing road salt. However, the combination of the effects of spillage from the storage bin and the effects of ADB could accumulate to increase stress levels within the tree which could exacerbate the issues

T1/464 Common ash – note the symptoms of crown decline

- A recommendation to relocate the road de-icing bin away from trees has been made
- T2/465 Common ash is in such a condition due to the decay in the stem and the effects of ADB, that its removal has been recommended. This should be done as soon as practicable

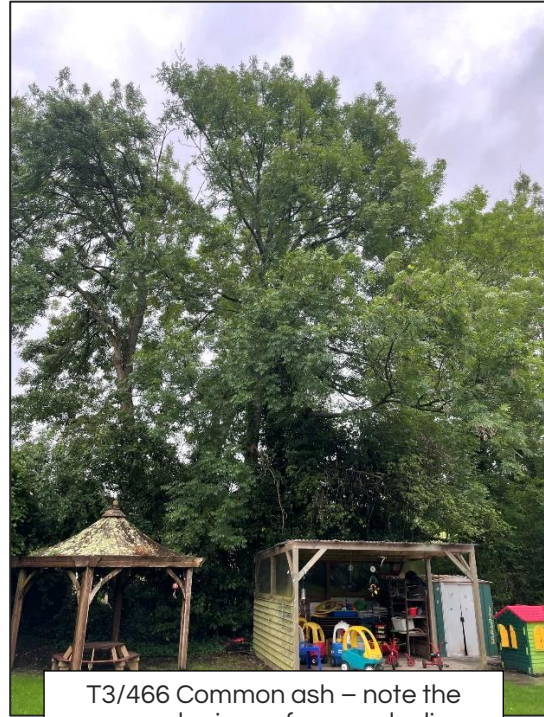
T3/466 Common ash – note the very early signs of crown decline

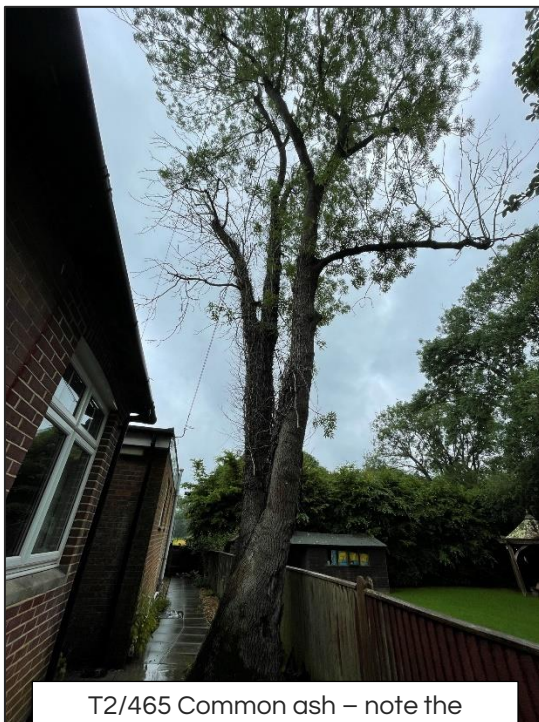
T2/465 Common ash – note the advanced symptoms of ADB

- Undertake the felling of T2/465 as soon as practicable
- Undertake the remaining work recommended in the time period specified
- Due to the nature of ADB, a reinspection date of twelve months from the reports date has been specified. This will allow for an appraisal of the tree's conditions during the main leaf bearing time and as such an evaluation of the extent of any decline
- This timeframe should be brought forward in the event the trees local environment changes significantly

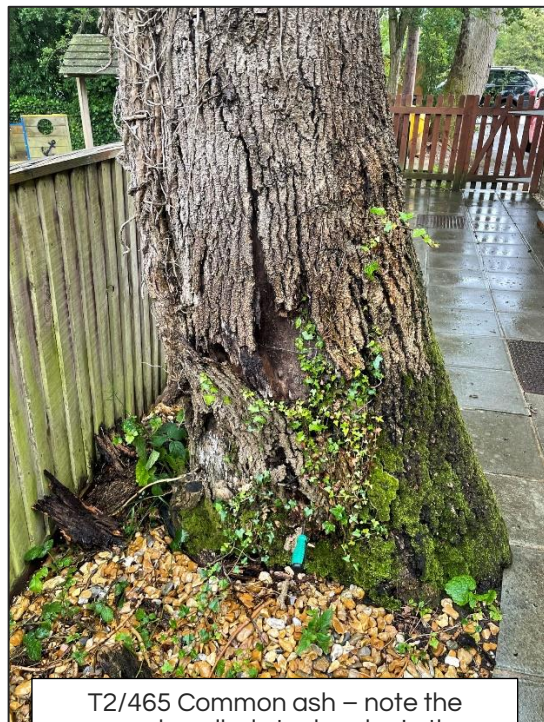
T2/465 Common ash – note the green handled steel probe in the base of the stem

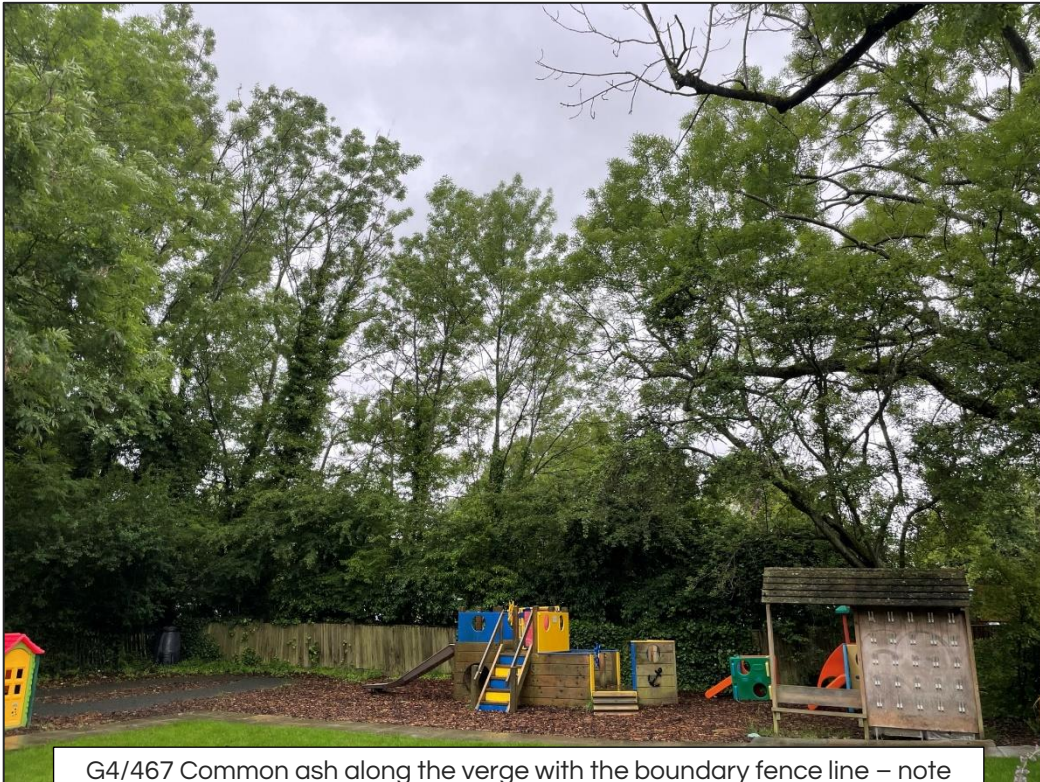
G4/467 Common ash along the verge with the boundary fence line – note the moderate symptoms of ADB with the crowns of the group of trees

- The ownership of G4/467 and T5/468 was unclear, hence not being tagged, but included within the report as their failure could impact on The Winterton Hall's boundary fence line. If known, the owner/s of these trees should be notified of their duty of care in relation to managing their liability in the event of tree failure
- If the tree is located within a conservation area or subject to a tree preservation order, a formal application to the local planning authority will be required and written consent obtained prior to any work is carried out

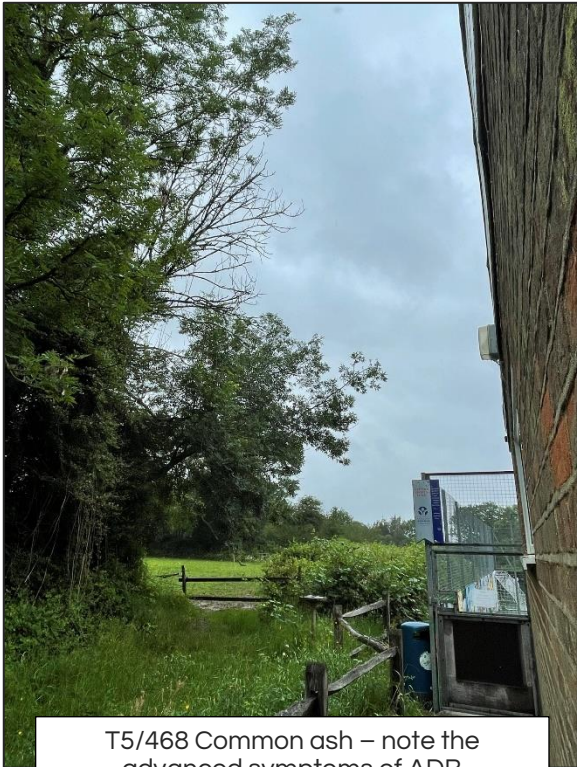
T5/468 Common ash – note the advanced symptoms of ADB
