Gale Tree Consultancy

Tree Condition Report

Plaistow Recreation Ground

Ref: TCR/297/22

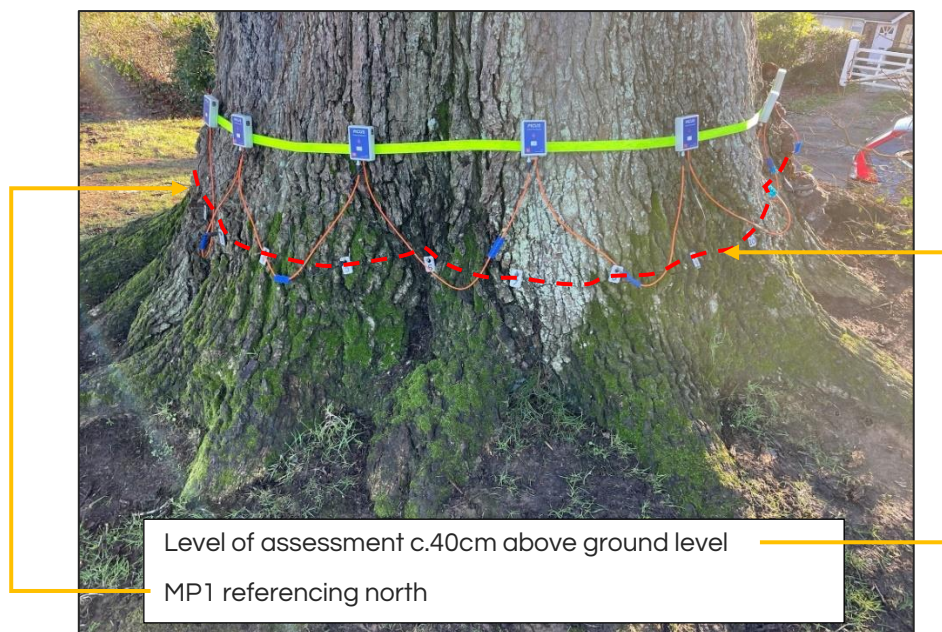
- To confirm the extent of any decay, the Picus 2 sonic tomography unit was used 40 cm above ground level (south side of the stem) with 30 measuring points (MP). MP 1 was placed at north for reference purposes – please see below:

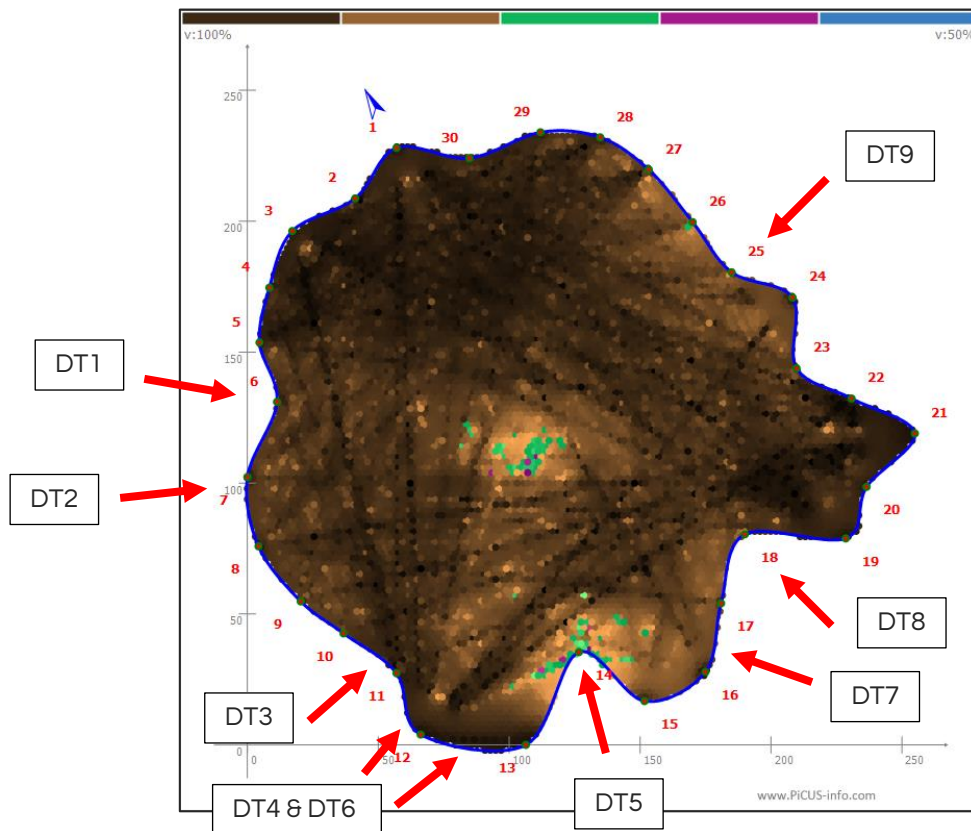
- The tomogram below indicates an area of high sonic velocity across the level of assessment as indicated by the brown colour – see below:

- The tomogram indicates high sonic velocity across the level of the assessment suggesting the cross section is free from any decay or dysfunction; however, a number of the drill traces contradict this

- Drill Trace 7 also indicates a slight change in resistance towards the end of the assessment suggesting an area of dysfunction has been reached
- The lightening in the brown colour around MP14 does suggests a change in wood structure which has been confirmed by the three drill traces

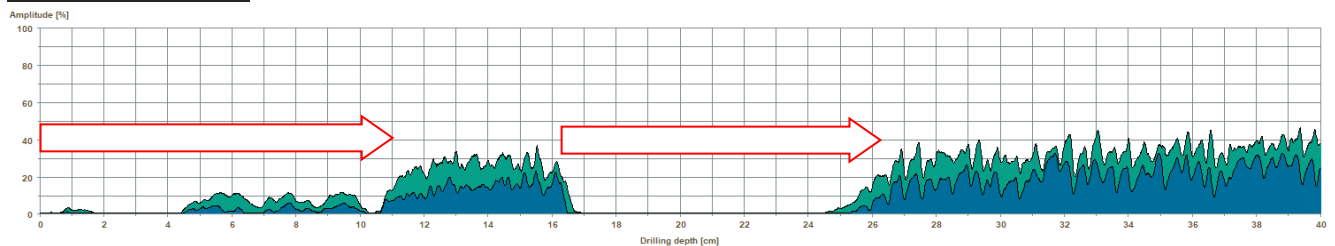
Drill Trace 1 – MP6

- The drill trace indicates two areas of low drilling resistance along the assessment length
- The first to a depth of c.10.5cm and the second between c.16.5cm and c.26cm; the remaining drill trace indicates sound wood is present

- Drill Trace 1 and Drill Trace 9 were undertaken where deeply fluted buttress roots have formed and it is my opinion that the drill was following the included bark layer and not an area of decay; where the drill encountered resistance, it had reached sound wood

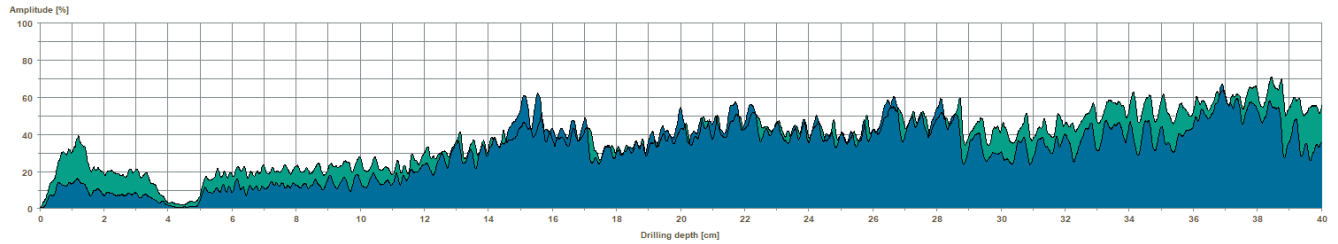
Drill Trace 2 – MP7

- The drill trace indicates sound wood along the length of the assessment

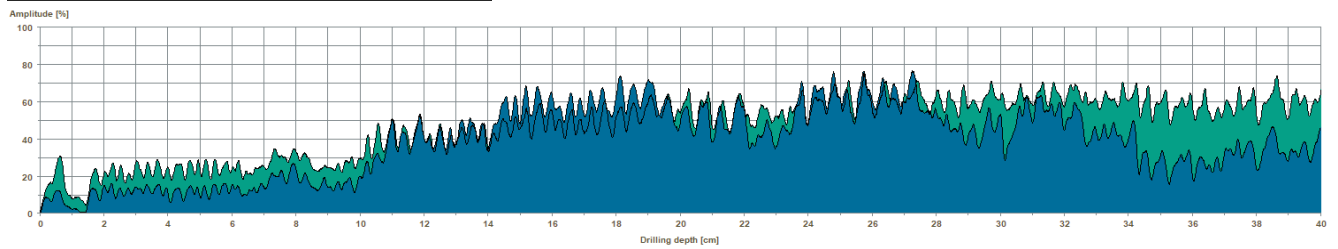
Drill Trace 3 – between MP10 – MP11

- The drill trace indicates sound wood along the length of the assessment

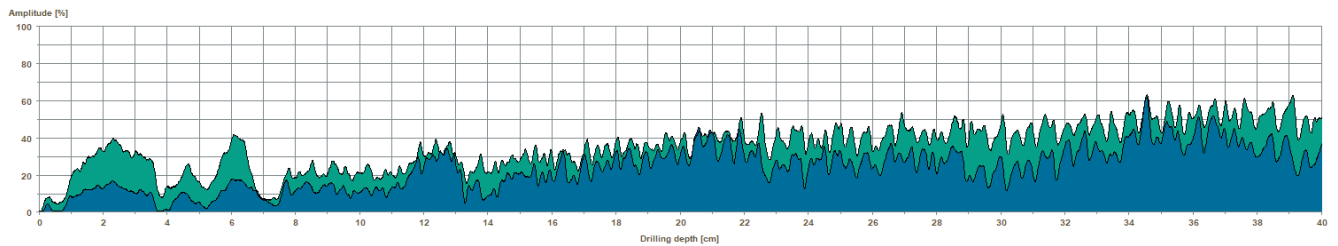
Drill Trace 4 – MP12

- The drill trace indicates sound wood along the length of the assessment

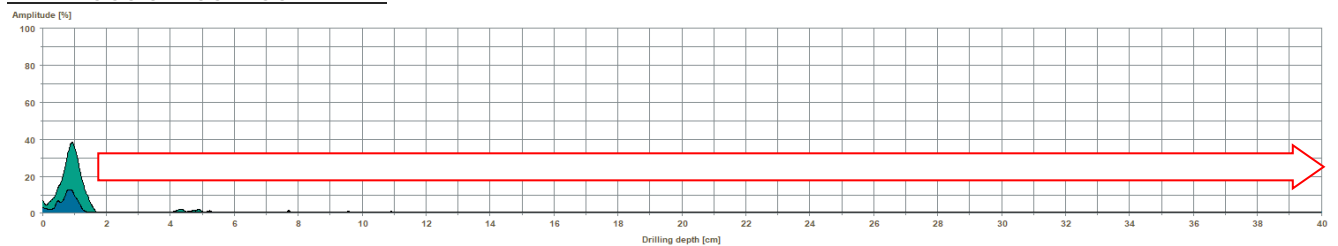
Drill Trace 5 – between MP14

- The drill trace indicates extensive decay/hollowing

- Drill Trace 5 undertaken at MP14, the location of the *Pseudoinonotus dryadeus* fruiting bodies, does indicate extensive decay has formed
- Drill Trace 6, which was undertaken pointing towards the area of fruiting bodies and not towards the centre of the tree. This was done to 'pick up' any decay that maybe migrating away from the point of the fungus, which it does

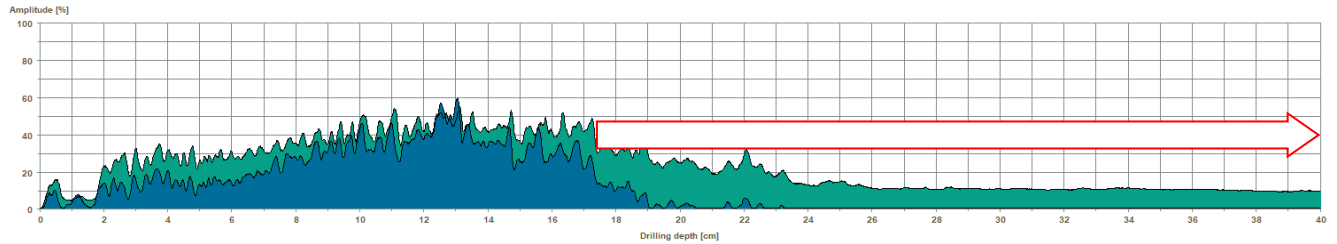
Drill Trace 6 – MP12-13

- The drill trace indicates an area of extensive decay forming from c.17.5cm through to the end of the assessment

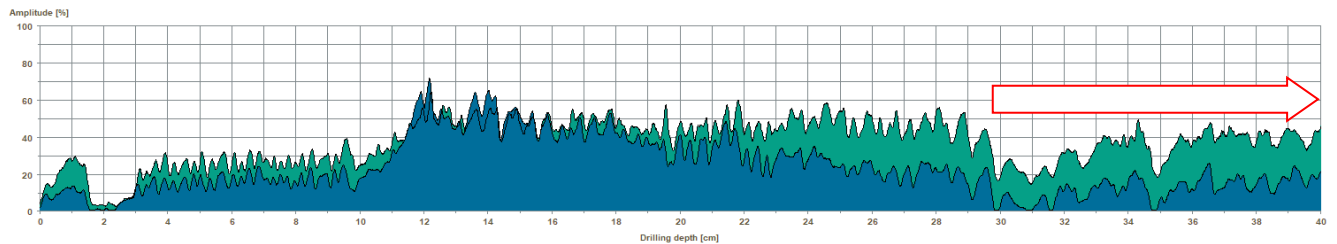
Drill Trace 7 – between MP16 – MP17

- The drill trace indicates sound wood is present to a depth of c.30cm
- From c.30cm to the end of the assessment, the resistance becomes more variable in nature suggesting an area of dysfunction has been reached

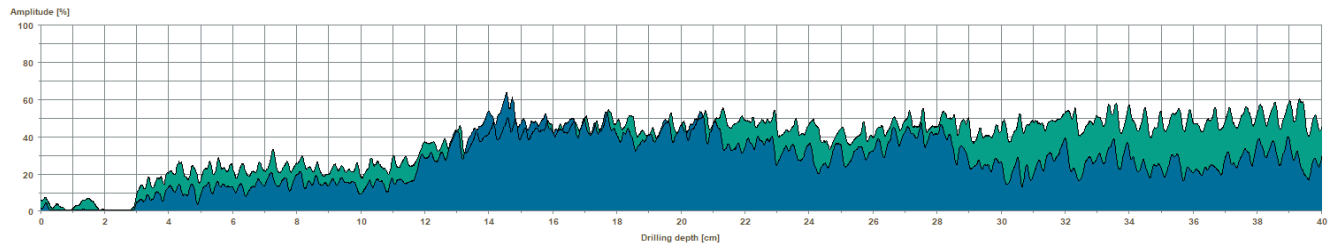
Drill Trace 8 – MP18

- The drill trace indicates sound wood along the length of the assessment

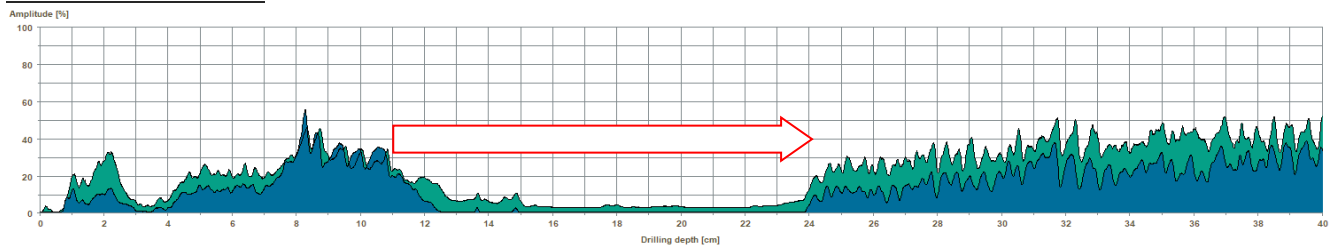
Drill Trace 9 – MP25

- The drill trace indicates an area of incipient decay/decay forming from c.11cm through to c.24cm
- From c.24cm, the drill trace suggests sound wood is present

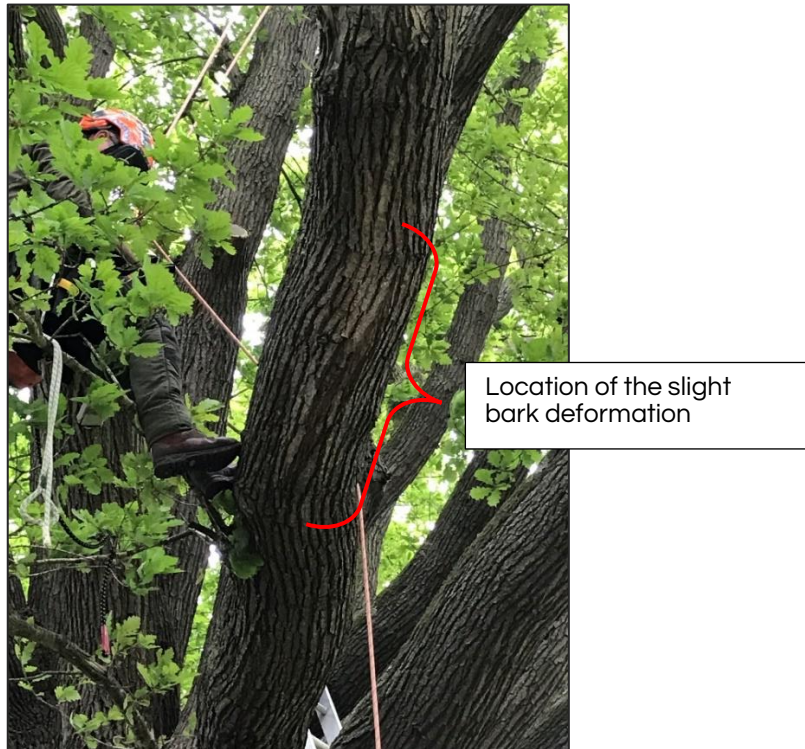
1 – Secondary Stem Section at c.4.7m heading east

- On its underside, the stem section has a slight deformation in the bark contour suggesting a possible crack may have occurred and subsequently occluded

- The drill assessment does not indicate any significant change to suggest an alteration in the wood structure

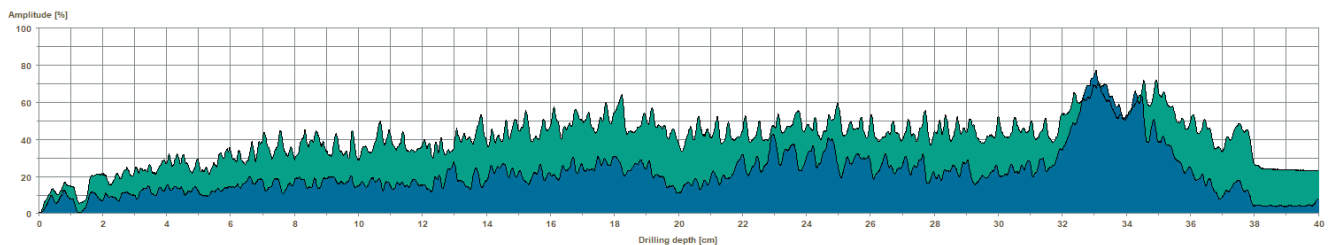
Drill Trace 10

- The drill trace indicates a slight change in resistance around c.20cm suggesting a possible area of altered wood
- The drill exits the stem section at c.38cm

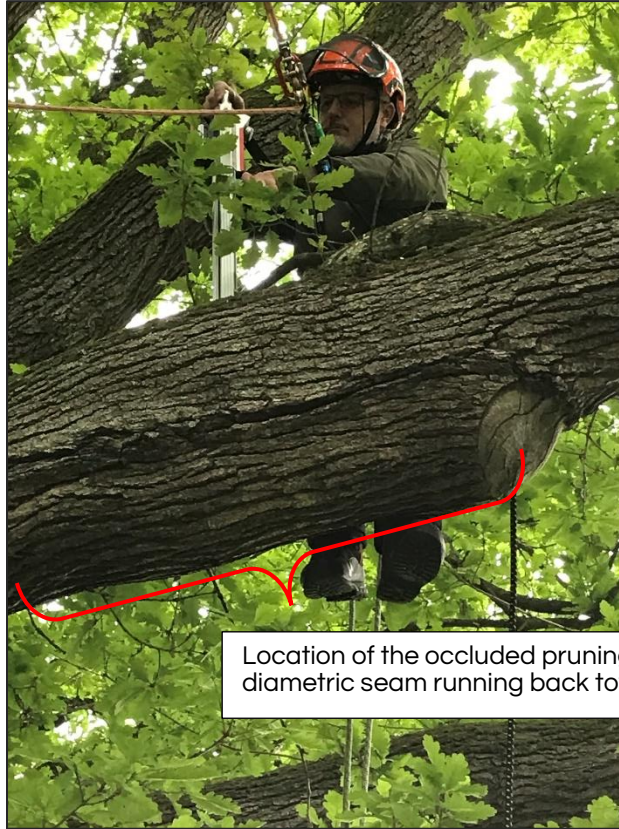
2 – Secondary Stem Section at c.4.7m heading north east

- On the underside of the stem section is an occluded wound of a removed tertiary stem section. Radiating back towards the main stem is a long seam which appears diametric in nature

- The assessment from both sides of the stem suggests an area of dysfunction within the central area of the stem. However, either side of this area, the wood exhibits high resistance to the drill and therefore, sound wood
- This stem section is being shortened as part of another phased piece of work, and in my opinion, this should help to alleviate any loading on the area of dysfunction

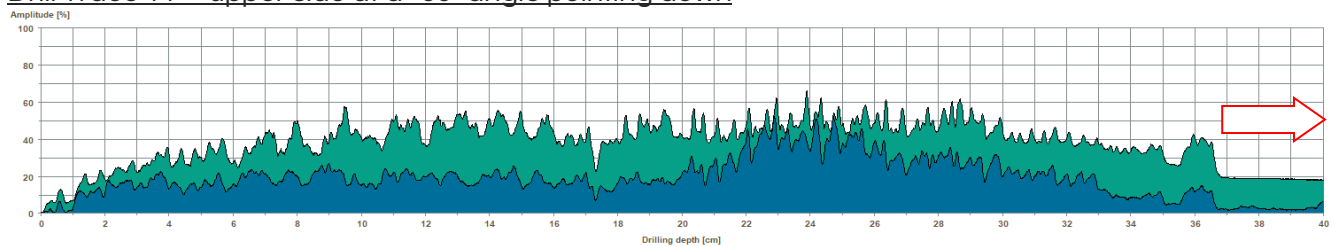
Drill Trace 11 – upper side at a -60° angle pointing down

- The drill trace indicates a decrease in resistance to the drill from c.26cm before entering an area of decay/hollowing from c.37cm
- This suggests that towards the centre of the stem section, the wood structure is becoming compromised due to the effect of decay

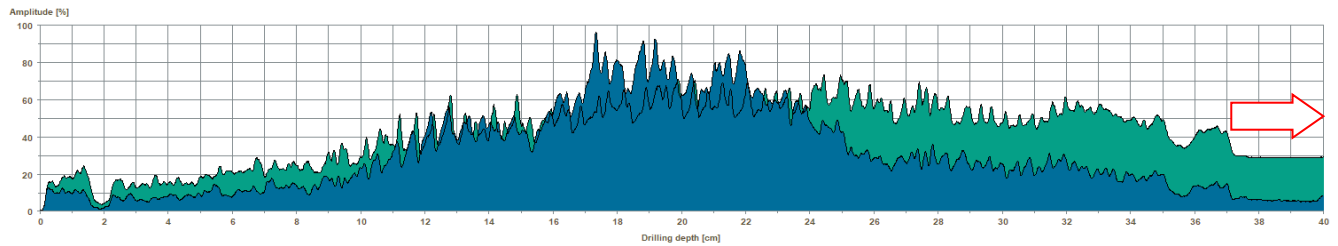
Drill Trace 12 – underside at a +40° angle pointing upwards

- The drill trace indicates a decrease in resistance from c.24cm before entering an area of decay/hollowing from c.37cm
- This suggests that towards the centre of the stem section, the wood structure is becoming compromised due to the effect of decay

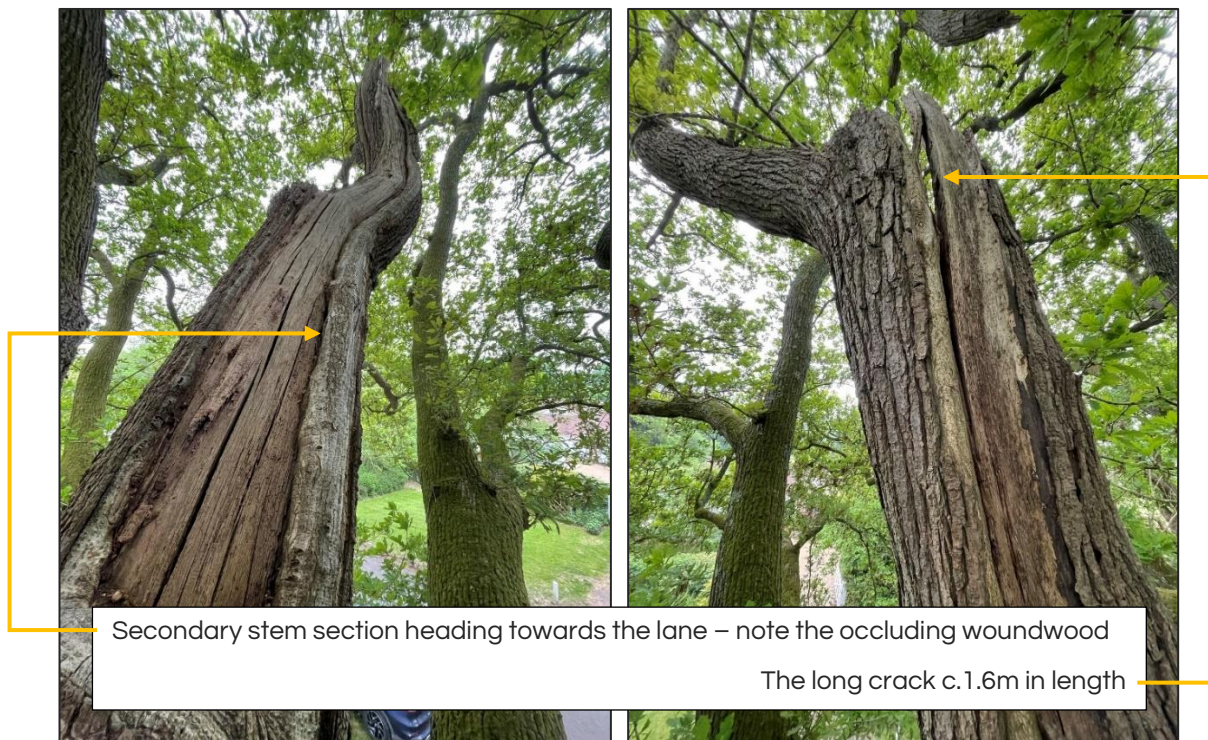
3 – Secondary Stem Section at c.6m heading east

- A long stem section with a large open wound on its upper side starting from its attachment point with the main stem – see below. Woundwood¹ is being placed around the wound

- The stem bifurcates c.4m away from the point of attachment forming two tertiary stems, one of which has been removed
- A crack has formed at the point where the tertiary stem was removed, which runs down the stem to a length of c.1.6m – see the right hand photo above

- The crack extends down the stem for c.1.6m, however, at its mid-point, the drill trace indicates the wood structure is sound with only a small crack forming at c.15.5cm to suggest its presence
- There is a risk that the stem could fail at the 'pivot' point where the crack meets the sound wood. In my opinion, this is unlikely as the surrounding crown structure is acting as a buffer from any wind loads that could otherwise affect it

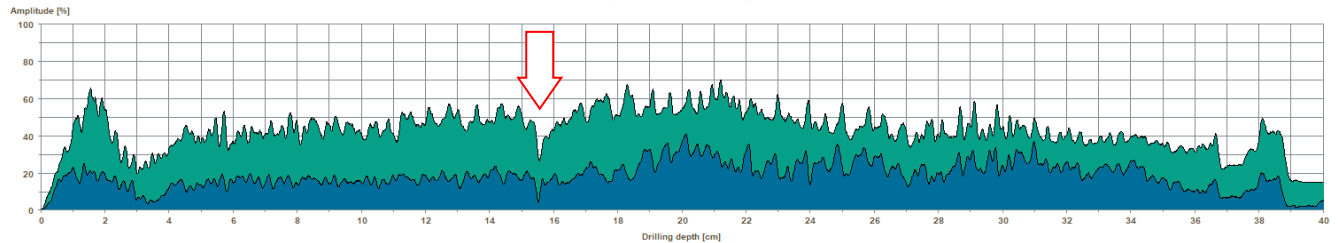
Drill Trace 13 – upper side of stem at a -17° angle pointing down

- The drill trace indicates an increasing resistance to the drill with a sharp drop at c.15.5cm suggesting the drill breached the crack that's migrating down the stem section
- The drill exited the stem section at c.39cm

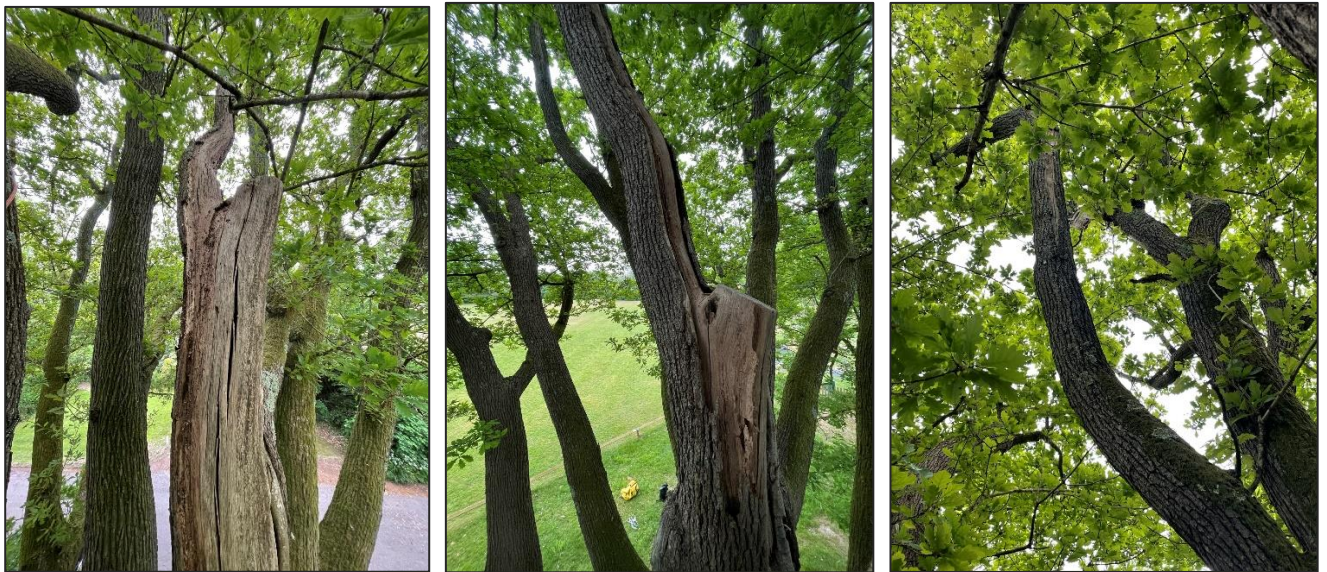
4 – Central Crown Secondary and Tertiary Stem Sections

- Within the central area of the crown area number of stems sections with areas of bark missing along their lengths with the majority extending in a westerly direction; however, one does extend out towards the lane – see the photos below:

- Many of the sections have occluding woundwood forming
- However, in some places, the outer edge of the bark layer is becoming friable in nature suggesting decay is continuing unchecked

- The new low level fence erected beneath the western crown affords members of the public some protection should any stem section fail
- However, the fence does not fully encapsulate the westerly crown meaning any failure of the upper branches outside the fence line, could result in them reaching the ground where members of the public are allowed
- The tertiary stem section that heads eastwards towards the lane is short and in the event it were to fail, would more than likely become suspended

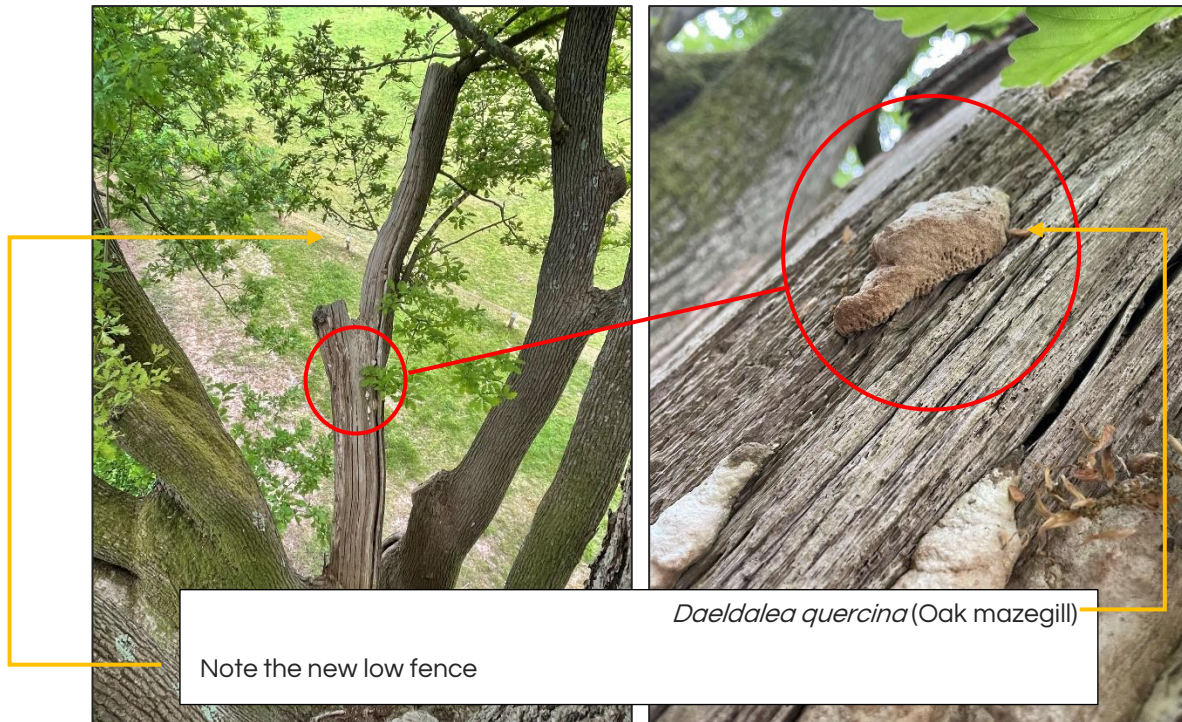
5 – Secondary Stem Section at c.4.5m heading west

- A truncated stem section with c.70% of the bark layer missing from its point of attachment to the end of the pruned stem – see below:

- Approximately 1.5m out from the point of attachment are fruiting bodies of the decay fungus *Daedalea quercina* (Oak mazedgill). It is saprotrophic on dysfunctional and/or dead sections
- The new, low fence can be seen below the western crown spread

- *Daedalea quercina* (Oak mazegill) is a saprotrophic decay fungus where it lives on dead and dysfunctional wood. It is not known to cause failure of the host branch or stem section
- Its presence alone is not a cause for concern but does allude to the degradation of the wood structure

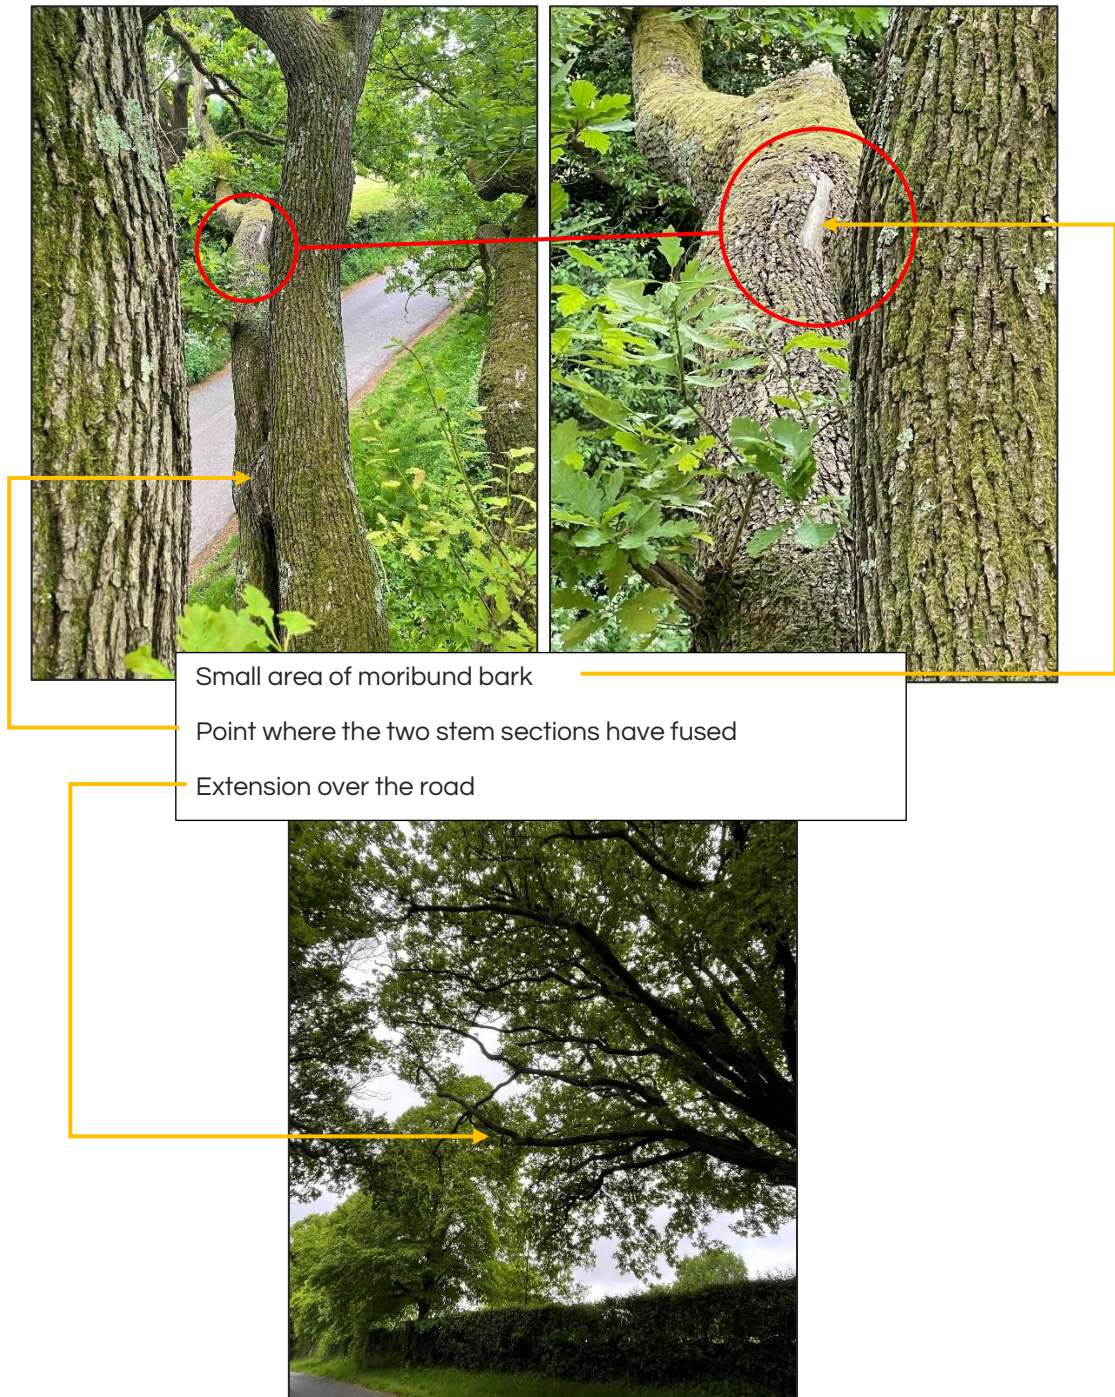
6 – Secondary Stem Section at c.4.8m heading south

- A long stem section that has fused with its neighbour directly above, both head south over the lane
- The bottom section has small area of moribund bark on its upper side – see below

- The small moribund bark on the upper surface of the stem section suggests an area of dysfunction is beginning to form, sufficient to cause the decline of the bark layer at this point
- At the time of the assessment, I do not consider the area to warrant any further action
