## PROW Resurfacing List

### **3. PROW Improvement Request : Ifold PLA 624-1 LOX 624-1**

#### **4. PROW Improvement Request : Ifold PLA 235 – PLA 644**

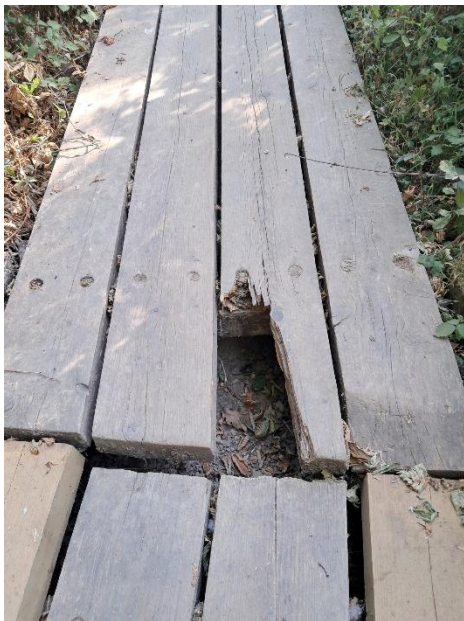
1.

2. Your recent newsletter requested details of those PROWs requiring repair and i attach pics showing a wooden boardwalk from Ifold to Loxwood. A popular route for Ifolders walking to the Surgery at Loxwood or accessing the shops.

Don t have precise location but just off the Tow path and across the bridge to access the fields behind Loxwood Farm development.

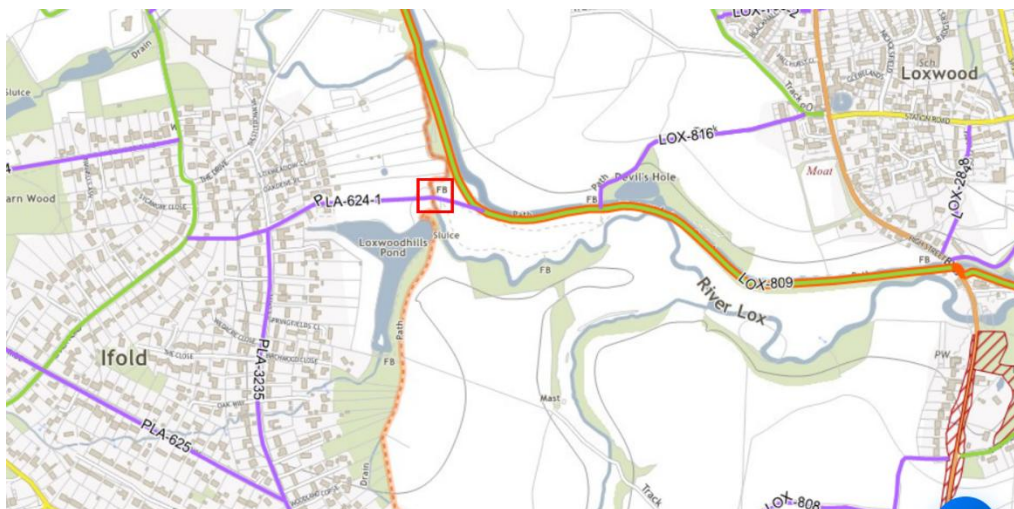
The request relates to a stretch of about 10 M of Footpath that connects PLA 624 -1 to LOX 624 -  
The area is on the Loxwood side of the footbridge that crosses the River Lox . The location is highlighted by the Red Box on the attached PROW Map .

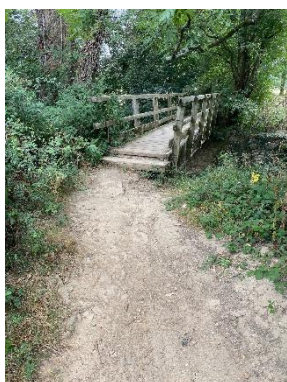
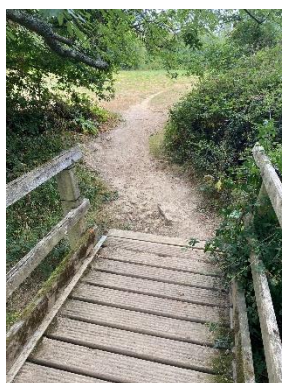
The footpath on the Ifold side of the bridge is in good condition. However, as you enter the Loxwood side of the bridge it has become eroded with flood water and a significant dip has formed which fills with water for much of the winter months making it very difficult to safely step off the bridge. The path needs to be built up to avoid deep puddles forming in the clay and further erosion or alternatively a short wooden walkway put in place, recognizing the River does flood occasionally during the winter .

The attached photos of the improvement area were taken in July 2026. Consequently, there is no standing water or churned clay. However, it is possible to see that the path has fallen away from bridges concrete steps and it dips significantly beneath the ground level of the path as it continues across the field .

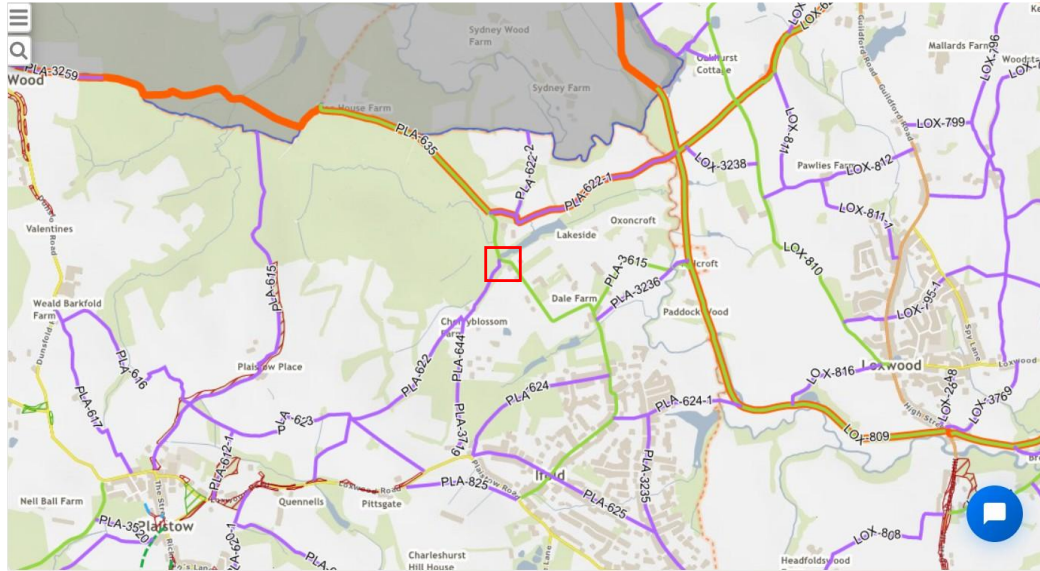
The request relates to a stretch of about 30 M of Bridleway that connects The Lane (PLA 235) with the Forestry Road (PLA 644) . Red Box on the attached PROW Map .

While both The Lane and The Forestry Road are wide paved / gravel tracks the stretch highlighted is uncovered clay. In the winter it becomes very heavily churned by horses and bikes which makes it difficult to use from October - April. This link is popular for many residents on foot and bike as the two tracks have limited vehicular traffic. If the surface was improved it would promote year round pedestrian and bike connectivity between Ifold and Plaistow, also between Ifold and the Wey and Arun Canal, and in turn onward to Rosemary Lane which connects to Alfold .

The attached photos of the proposed improvement area were taken in July 2026. Consequently, in the first photo much of the churned clay has become dried and flattened, however it is possible to see in the second two pictures the problems experienced in the winter from the residual dried churned path. A lower cost solution may be to work with the Forestry commission as their gated track is the most level route between the two PROWs.
