Safety Inspection Report

Annual Inspection

The Green

Plaistow and Ifold Parish Council

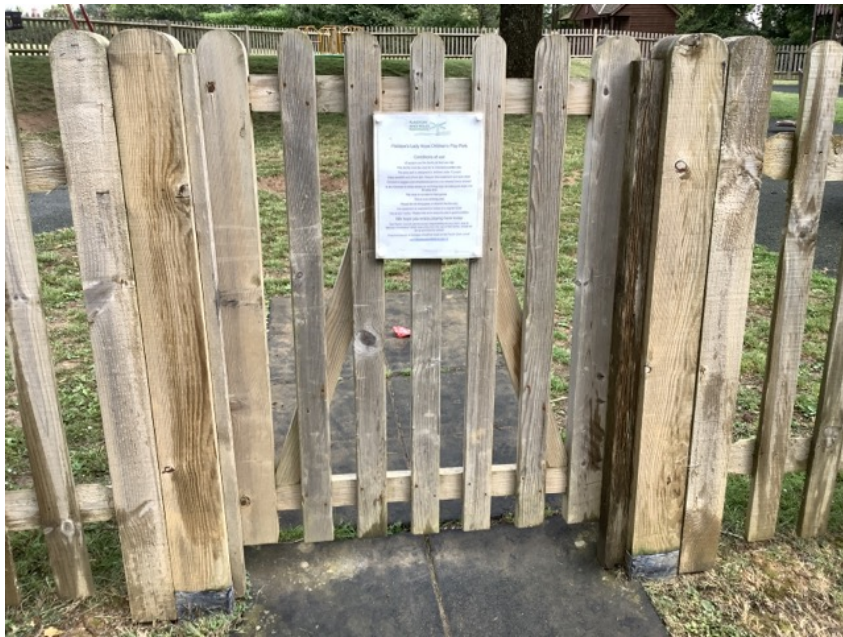
Gates - Pedestrian

There is a crushing or shearing point on the side of the gate. Where the gaps reduce to less than 12 mm these have been known to cause serious, permanent injury to children, especially on the hinge side where the leverage forces are significant.

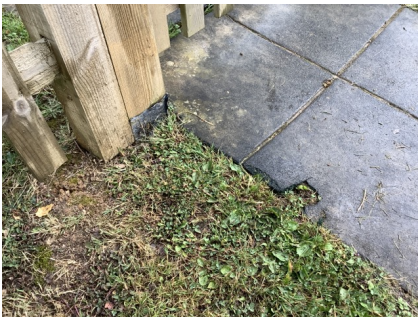
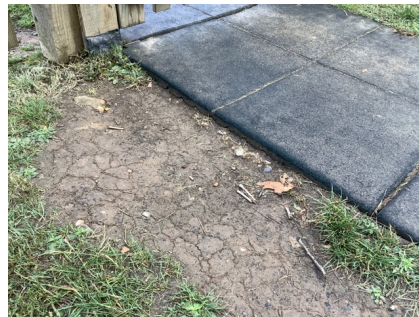
Trip points on the surface.

At sides of matting.

Make level.

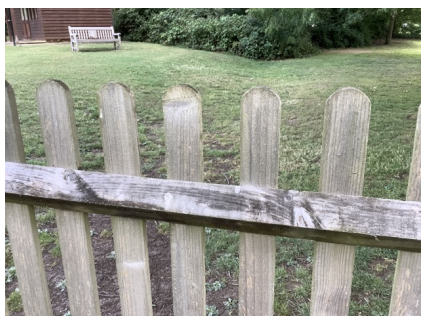
There is a neck entrapment in the top of the fence. Whilst fences are not playground equipment, the CEN technical report CEN/TR 16879:2016, clause 4.3.4 advises that fencing close to playgrounds should comply with the entrapment requirements of EN 1176-1.

Modify to comply with EN 1176.

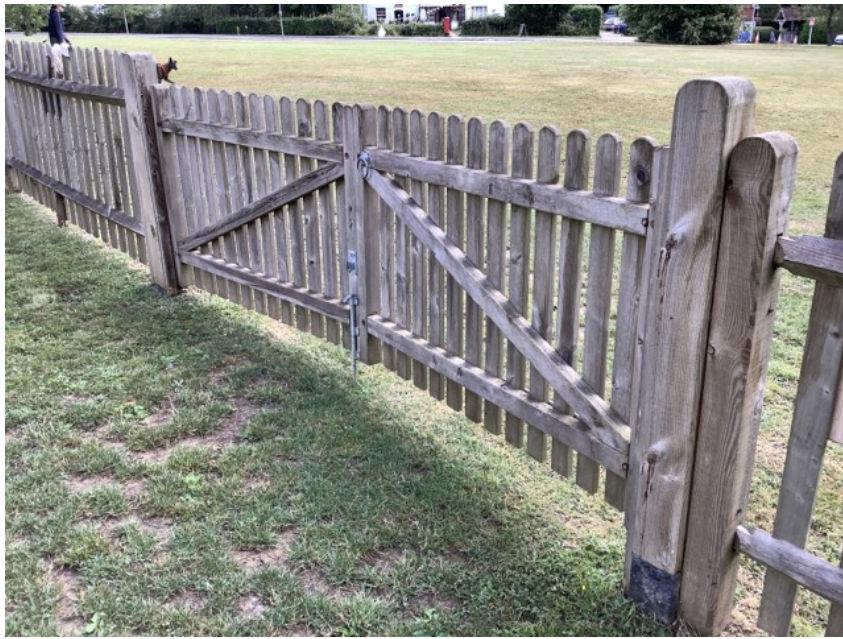
Gates - Maintenance

There is a crushing or shearing point on the side of the gate. Where the gaps reduce to less than 12 mm these have been known to cause serious, permanent injury to children, especially on the hinge side where the leverage forces are significant.

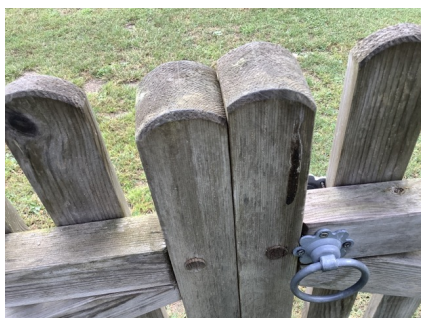
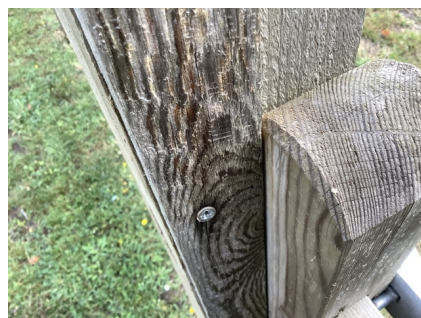
If unlocked.

Adjust gate / posts / fit new rubber buffer to ensure a spacing of at least 12 mm throughout the range of the gate to remove the entrapment. The 12 mm gap also should apply on the hinge side of the gate.

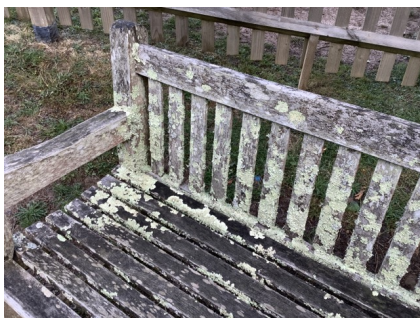
Moss is present.

Remove.

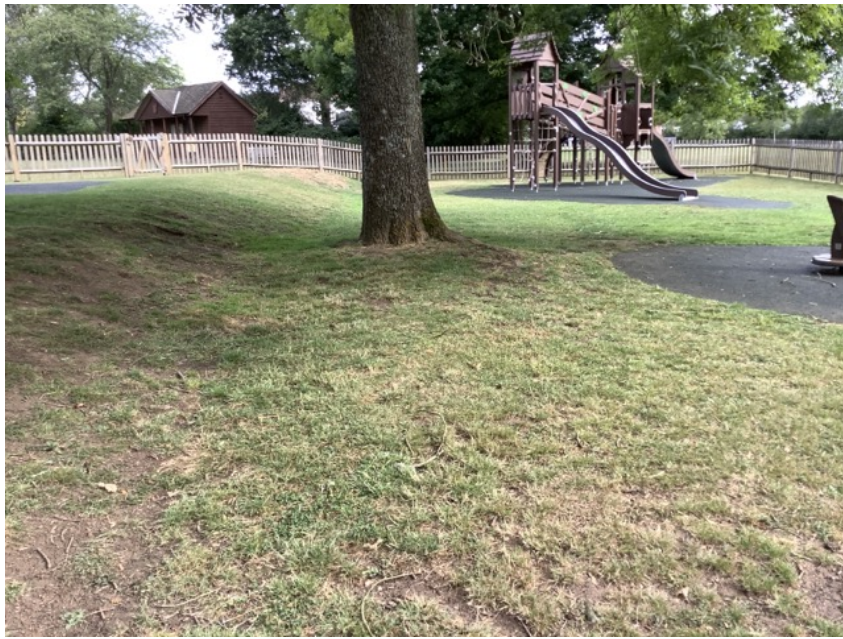
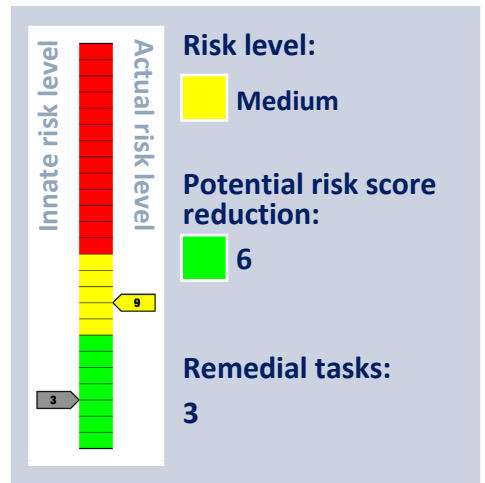
General Surface

Surface worn and has hole, which are trip hazards.

Repair.

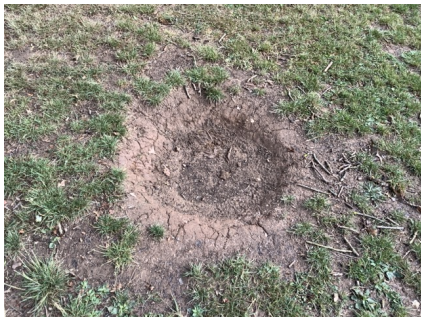
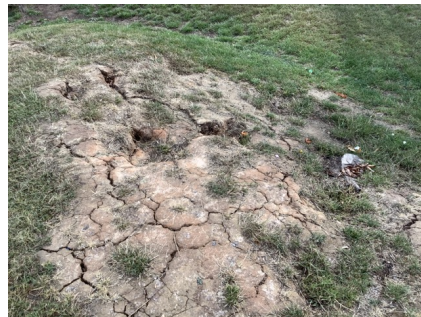
Surface has holes in it.

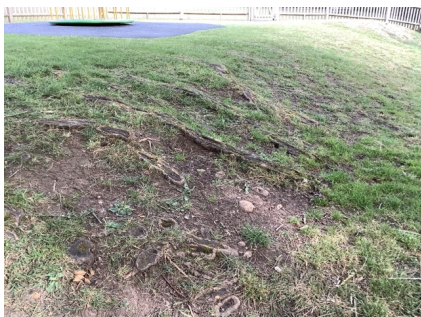
Trip points on the surface.

Exposed roots are a trip hazard. Cover with grass.

Remove trip points.

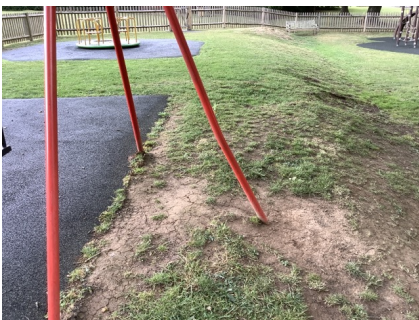
Item is bent.

End retaining support pole nearest Ash tree. Monitor and check on a routine basis.

No reasonably practicable action is identified.

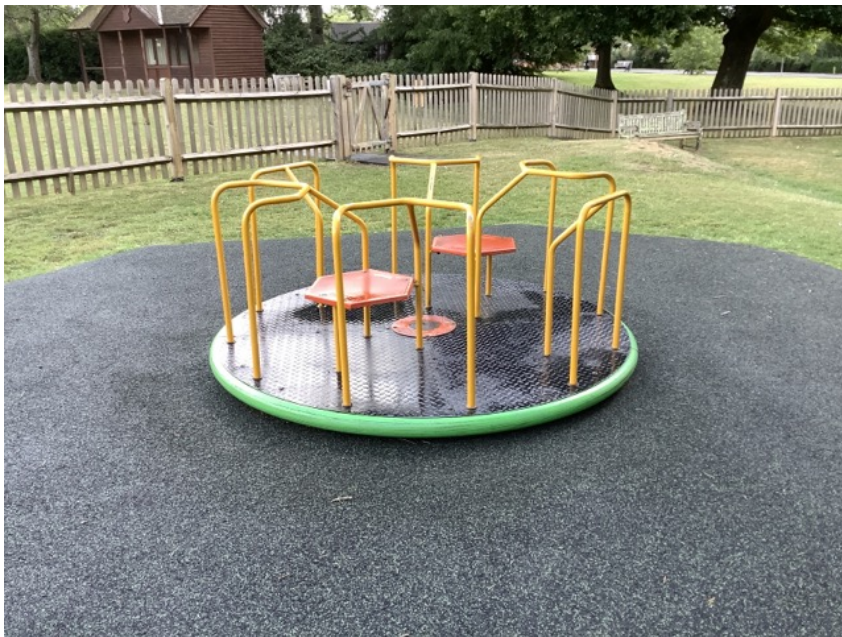
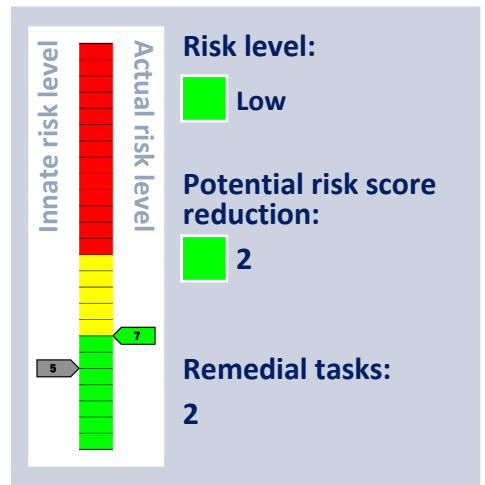
Carousel

There is wear in the bearings.

Monitor and replace when necessary.

Re-install roundabout or adjust surfacing. Recommended height 60-110 mm for 300 mm from edge.

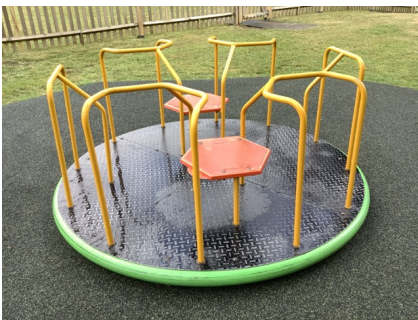
Lateral and vertical movement in unit. Monitor, as bearing may require a service shortly.

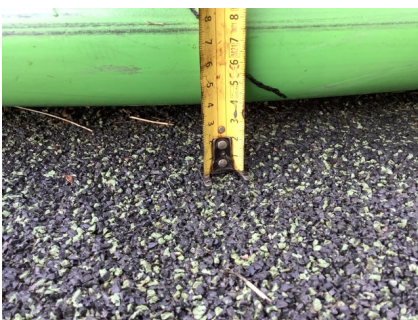
Clearance between the underside of the roundabout and the surface is incorrect.

Gap varies from 40 mm to 80 mm. Refer to supplier.

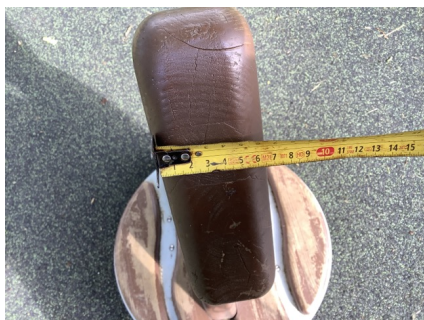
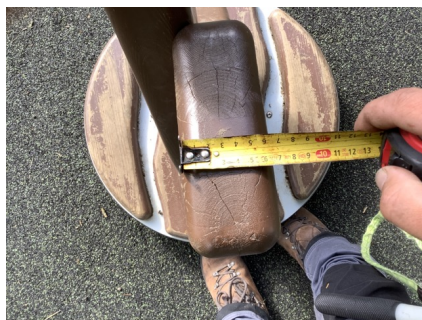
The centre pole does not meet the grip or grasp requirements.

Refer to the manufacturer for comment.

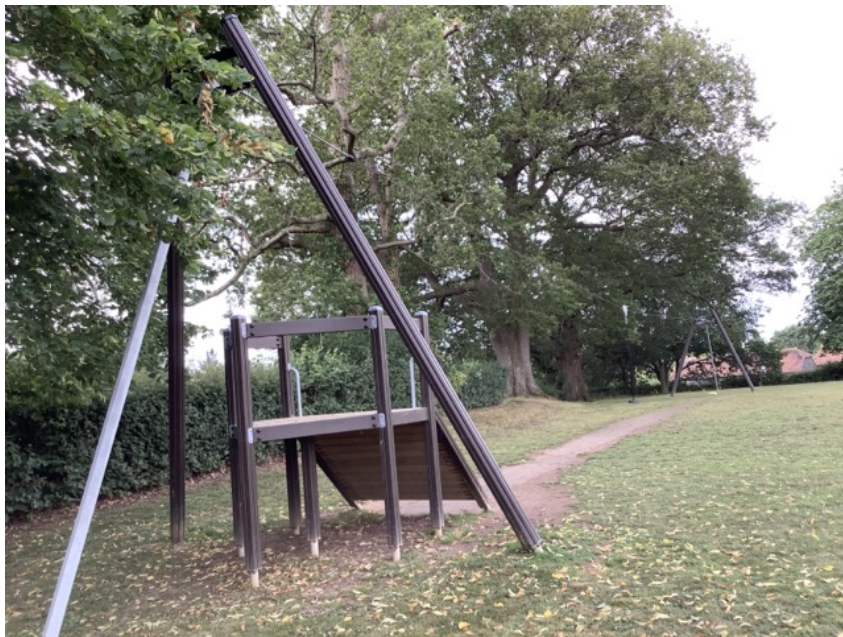
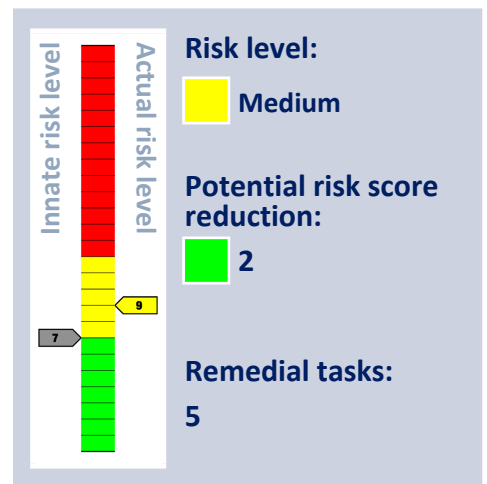
Runway - Cable - New

Cables have been known to fail under load due to wear and corrosion. This is generally where the cable enters into a tube, top bar, sleeve or similar, where the wire is in contact and wears and frays over time, but can happen anywhere on the cable. It is important to inspect any hidden parts at least annually. Damaged cables require replacement. This cannot be determined during an annual inspection, and is excluded from our inspection. This can lead to a high risk if no action is taken. Refer to the manufacturer's instructions to ensure the correct check is carried out.

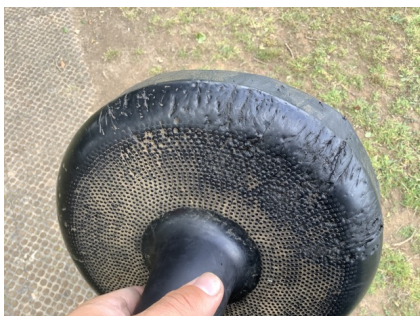
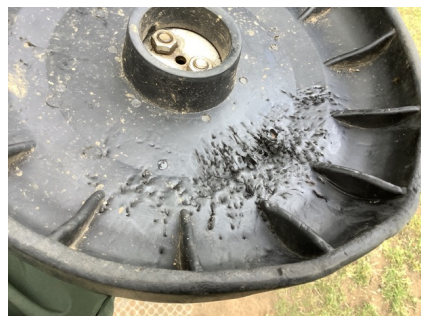
Item has dog damage.

Seat damaged, this is dog damage.

Repair.

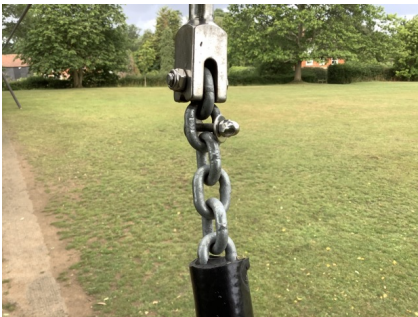
Minor repairs are needed.

Chain cover has torn away from bolt.

Repair.

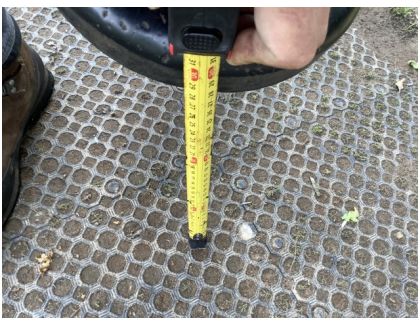
It is considered that the runway will have insufficient ground clearance under seat.

Modify to give a minimum 350 mm clearance under load.

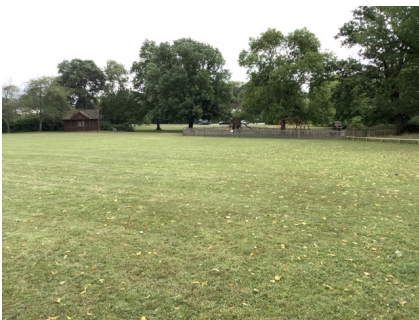
Additional comments are noted below.

Balls could land in play area during game play. Reinstall warning signs if cricket games restart.

Read the notes for further action.
