PLAY AREA SAFETY INSPECTION REPORT

Plaistow and Ifold Parish Council

09 June 2017

Site Owner : **Plaistow and Ifold Parish Council**
Site Name : Plaistow and Ifold PC - Village Green
Date of Inspection : 09 June 2017
Inspected by : Peter Mann

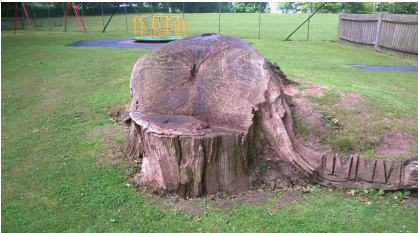
Seating - Oak Tree Risk Score : 3 Risk Level : Very Low	Seating	Finding : Timber - Decay

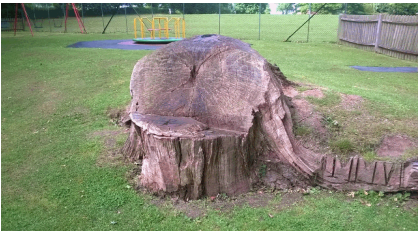
Low	5
Seating - Oak Tree Risk Score : 3 Risk Level : Very Low	Seating	Task : No action given the risk assessment Finding : Timber - Splintered

Notes : Sharp edges at seat support - round off sharp edges. Task : Remove splinters		
Seating - Picnic Table Risk Score : 4 Risk Level : Low	Seating	Satisfactory  		
Perimeter				
Fencing - Chain Link Risk Score : 4 Risk Level : Low	Fencing - Dog Proof	Finding : Item - Damaged

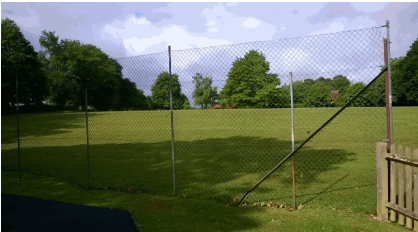
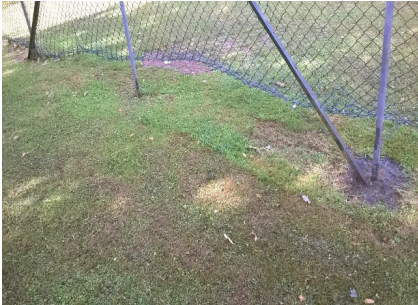
Notes : Top section near swings.

Task : Repair item	Low	5
Fencing - Timber Palisade Risk Score : 3 Risk Level : Very Low	Fencing	Finding : Item - Broken   Finding Date : 09/06/2017 Notes : Rails.	Medium	8

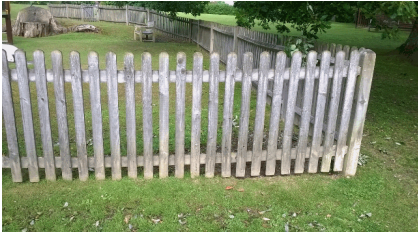
<p>Task : Repair item</p> <p>Finding : Item - Loose in Ground</p>

<p>Finding Date : 09/06/2017 Task : Secure fixing devices</p> <p>Finding : Item - Parts Missing</p>

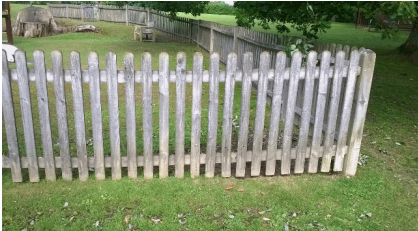
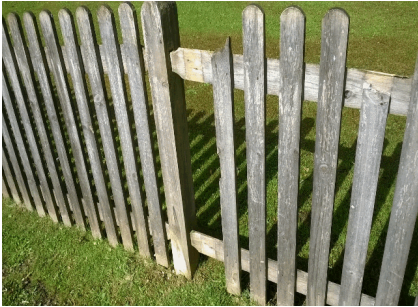
<p>Notes : Palisade x 1 near corner by multiplay.</p>

<p>Task : Replace missing parts</p>	<p>Low</p> <p>Low</p>	<p>6</p> <p>5</p>
<p>Gates - Maintenance</p> <p>Risk Score : 5 Risk Level : Low</p>	<p>Entrance</p>	<p>Finding : Item - Broken</p>	<p>Medium</p>	<p>8</p>

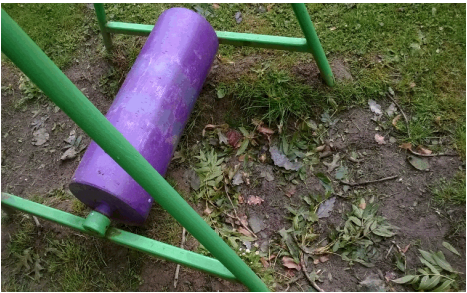
Agility Trail - Fun Run - 6 Units & 6 Step Links

Comments, action or control required		Risk Level	Risk Score ‡
Equipment			
Finding :	Dry bearings	Low	4
Notes :	Rolling barrel.		
Task :	Treat with oil, grease or silicon spray according to supplier's instructions		
Surfacing - Grass			
Finding :	Worn ground areas	Medium	8
Notes :	Foundations exposed at rolling barrel.		
Task :	Make good

The overall risk for this item at the time of inspection:		Medium	8
‡ For Risk Score see Report Notes

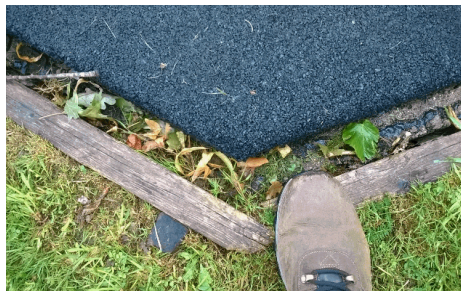
Carousel

Comments, action or control required		Risk Level	Risk Score ‡
Equipment	No remedial maintenance work is required at this time.		
Surfacing - Wet Pour			
Finding :	Surface - Perimeter of Surface Shrank from Edgings	Medium	8
Notes :	Trip hazard formed.		
Task :	Repair surface		
The overall risk for this item at the time of inspection: ‡ For Risk Score see Report Notes		Medium	8

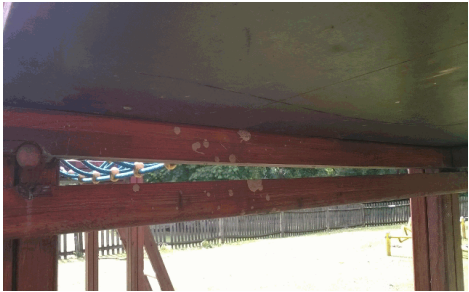
Multiplay - Tower - Woodland

The item fails to meet the requirement of the relevant standard.

Comments, action or control required		Risk Level	Risk Score ‡
Equipment			
Finding :	The equipment is easily accessible and leads to steep play elements	Low	6
Task :	Monitor and check on a routine basis		
Finding :	Item - Cracked	Medium	8
Notes :	Cross beams under decks.

Task :	Replace item		
Surfacing - Misc Grass Matting			
No remedial maintenance work is required at this time.			
The overall risk for this item at the time of inspection:		Medium	8
‡ For Risk Score see Report Notes

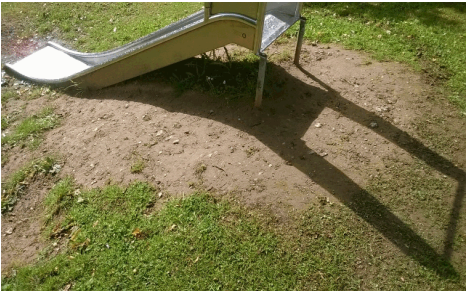
Slide - Embankment

Comments, action or control required		Risk Level	Risk Score ‡
Equipment	No remedial maintenance work is required at this time.		
Surfacing - Misc Grass Matting			
Finding :	Worn ground areas	Low	7

Task :	Make good		
The overall risk for this item at the time of inspection:		Medium	8
‡ For Risk Score see Report Notes
