Safety Inspection Report

Annual Inspection

The Green

02 July 2022

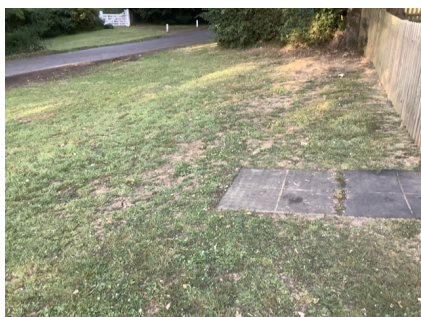
Car Parking

Additional comments are noted below.

Cars can park directly outside gate - Recommend installing barriers to reserve pedestrian space by gate.

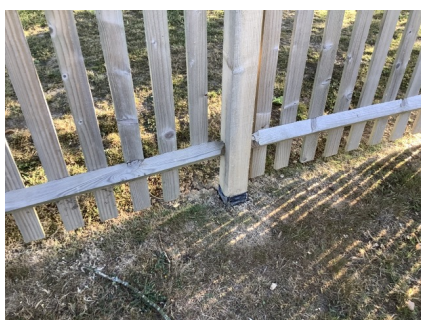
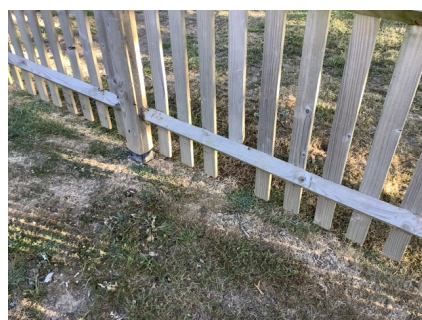
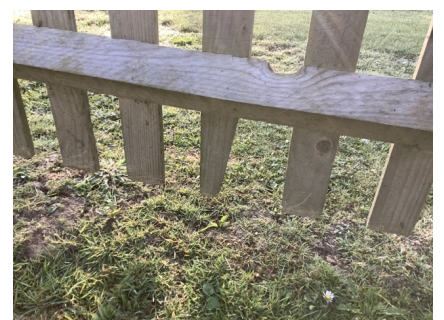
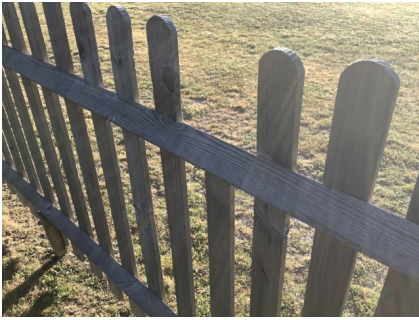
Fencing - Timber Palisade

Item is damaged.

Lower parts of some palisades.

Repair.

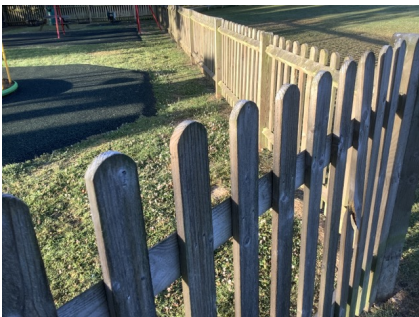
There is a neck entrapment in the top of the fence. Whilst fences are not playground equipment, the CEN technical report CEN/TR 16879:2016, clause 4.3.4 advises that fencing close to playgrounds should comply with the entrapment requirements of EN 1176-1.

Modify to comply with EN 1176.

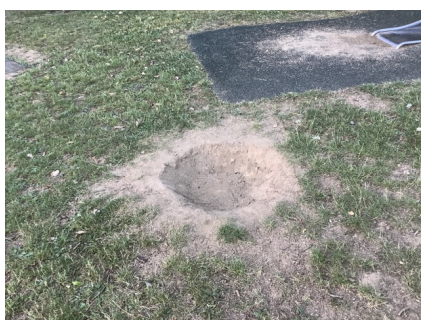
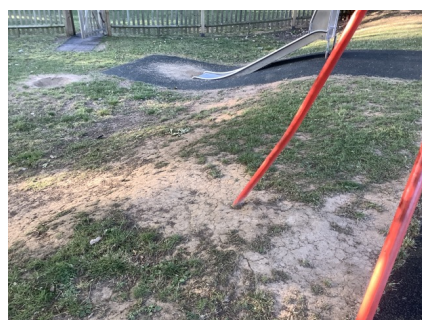
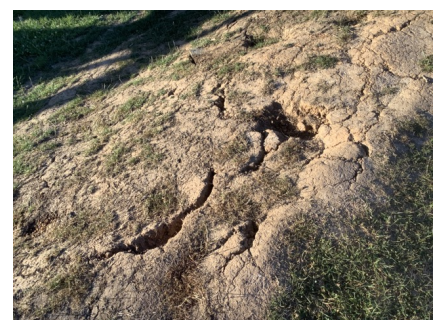
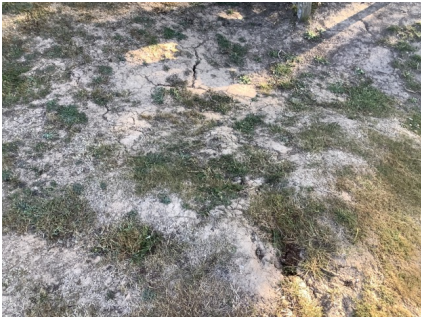
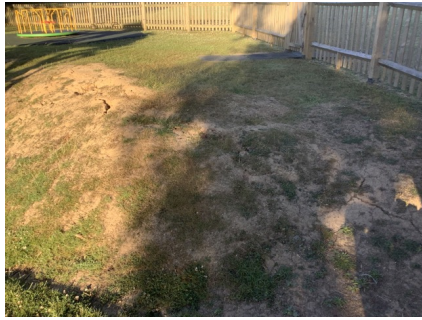
General Surface

Surface has holes in it.

Surface worn and has hole, which are trip hazards.

Repair.

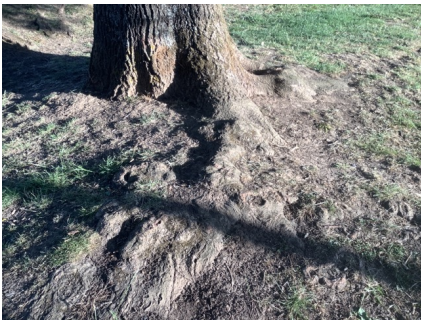
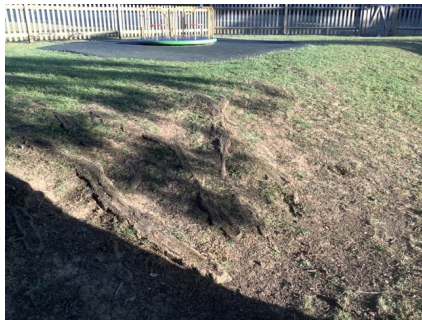
Trip points on the surface.

Exposed roots are a trip hazard - Cover with grass.

Remove trip points.

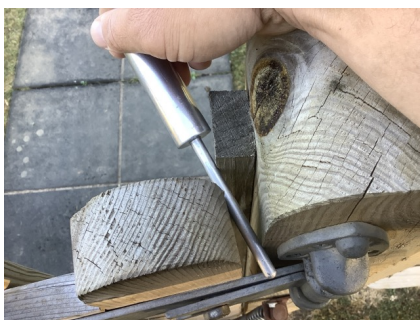
Gates - Pedestrian

Entrapment on side(s) of the gate.

Adjust gate / posts / fit new rubber buffer to ensure a spacing of at least 12 mm throughout the range of the gate to remove the entrapment. The 12 mm gap also should apply on the hinge side of the gate.

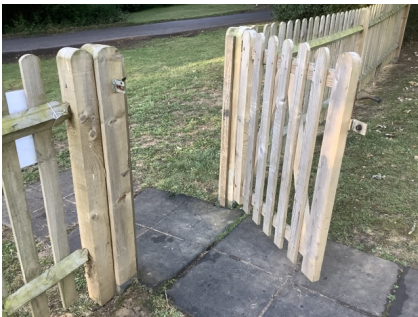
Item is not working.

Closer springs not fully closing gate.

Repair.

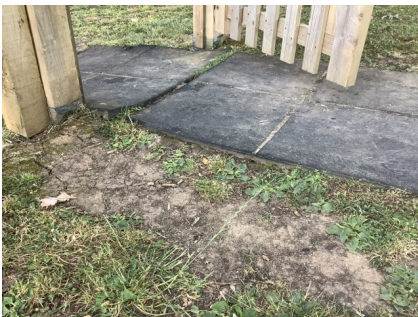
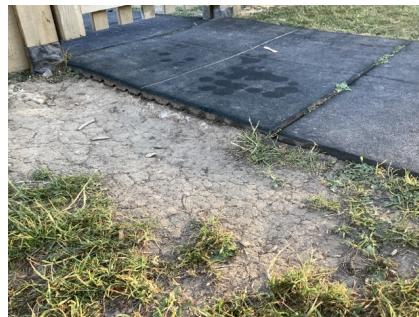
Trip points on the surface.

At sides of matting.

Make level.

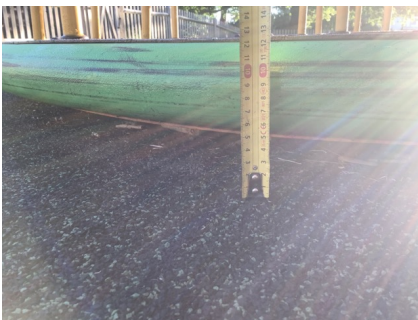
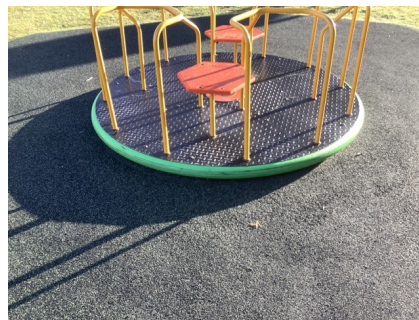
Carousel

Clearance between the underside of the roundabout and the surface is incorrect.

Gap varies from 50 mm to 80 mm - Refer to supplier.

Re-install roundabout or adjust surfacing. Recommended height 60-110 mm for 300 mm from edge.

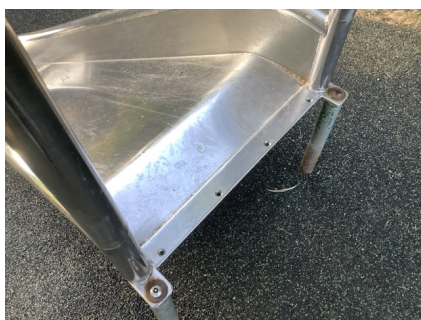
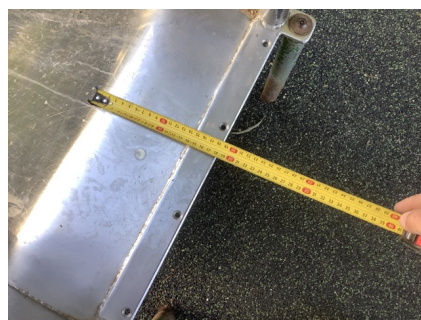
Slide - Embankment

The starting section of the slide is less than the minimum permitted length of 350 mm.

No reasonably practicable action is identified.

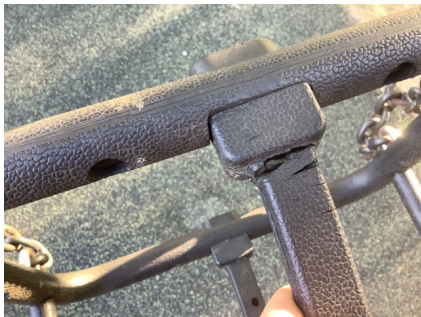
Swing - Mixed - 2 Bay 2 Junior 2 Toddler Seat

The swing seat has been damaged, but does not require immediate replacement.

At cradle crotch straps.

Monitor and replace when hard material is exposed.

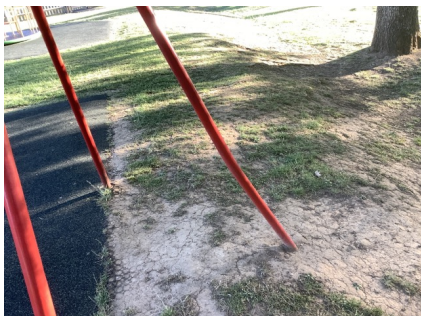
Item is bent.

End retaining support pole nearest ash tree - Monitor and check on a routine basis.

No reasonably practicable action is identified.

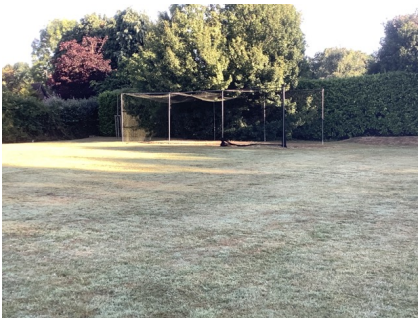
Cricket Wicket

Balls could land in play area during game play - Reinstall warning signs if cricket games restart.

Read the notes for further action.

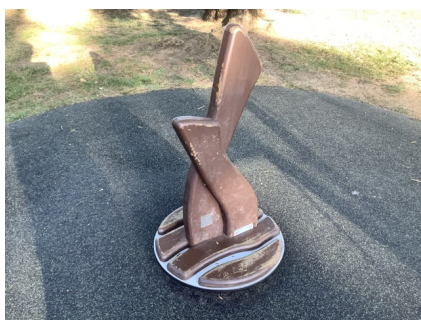
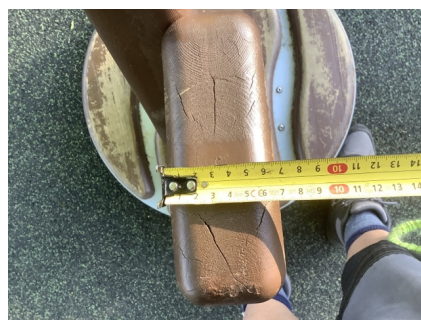
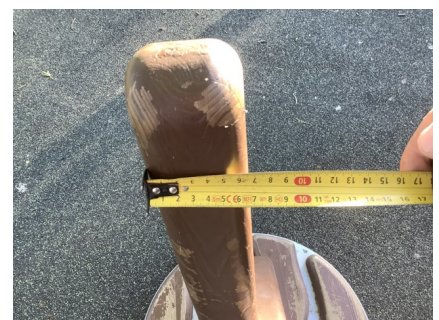
Carousel - Spinner Platform - New

The centre pole does not meet the grip or grasp requirements.

Refer to the manufacturer for comment.

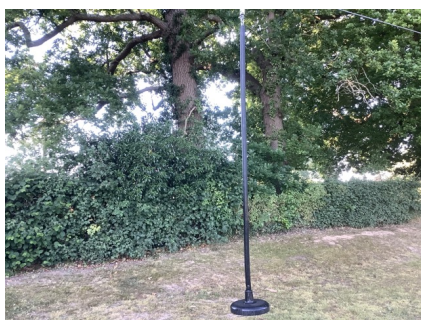
Runway - Cable - New

Chain covers prevent a thorough inspection of all chain links.

Remove chain covers to inspect according to manufacturer's instructions.

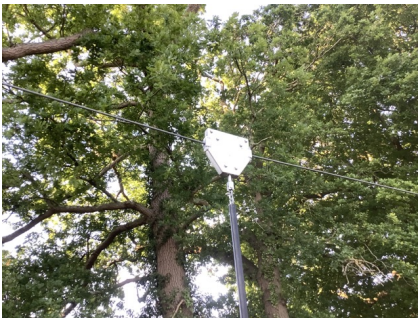
The supporting components should be dismantled and inspected according to the manufacturer's instructions. This will need doing on a regular basis.

Dismantle and inspect according to manufacturer's instructions.

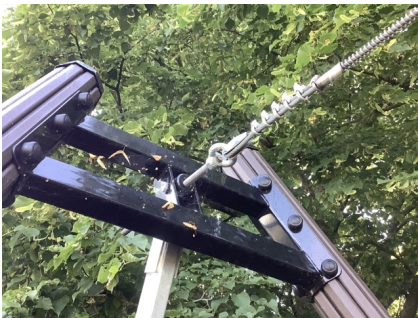
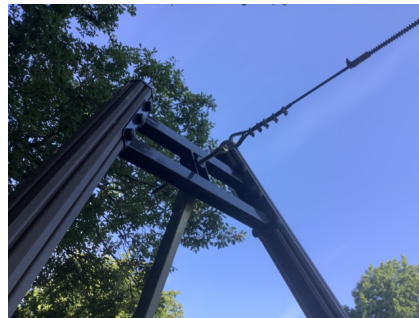
Cables have been known to fail under load due to wear and corrosion. This is generally where the cable enters into a tube, top bar or similar, where the wire is in contact and wears and frays over time, but can happen anywhere on the cable. It is important to carry out a full dismantling inspection at least once per year. Damaged cables require replacement. This cannot be determined during an annual inspection, and is excluded from our inspection. This finding is generically high risk and action is required. Refer to the manufacturer's instructions to ensure the correct check is carried out.

Conduct an appropriate dismantling inspection according to the manufacturer's instructions, and at least annually. The trolley mechanism can be checked at the same time.

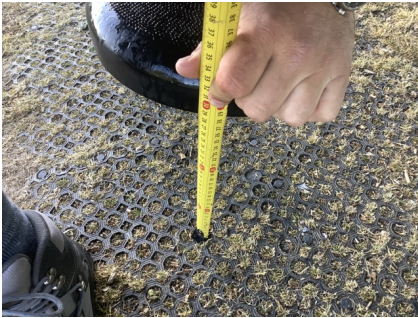
It is considered that the runway will have insufficient ground clearance under seat.

Modify to give a minimum 350 mm clearance under load.
